**Building Information - Cleveland Municipal (43786) - Joseph M Gallagher Middle**

Program Type	Classroom Facilities Assistance Program (CFAP) - Regular
Setting	Urban
Assessment Name	Joseph Gallagher MS OSFC Update (June 2016)
Assessment Date (on-site; non-EEA)	2016-04-01
Kitchen Type	Full Kitchen
Cost Set:	2016
Building Name	Joseph M Gallagher Middle
Building IRN	62778
Building Address	6601 Franklin Blvd
Building City	hmmh
Building Zipcode	44102
Building Phone	216-961-0057
Acreage	5.00
Current Grades:	K-8
Teaching Stations	52
Number of Floors	3
Student Capacity	927
Current Enrollment	750
Enrollment Date	2001-05-31
Enrollment Date is the date in which the current enrollment was taken.	
Number of Classrooms	48
Historical Register	<b>NO</b>
Building's Principal	Tom Kubiak
Building Type	Elementary/Middle

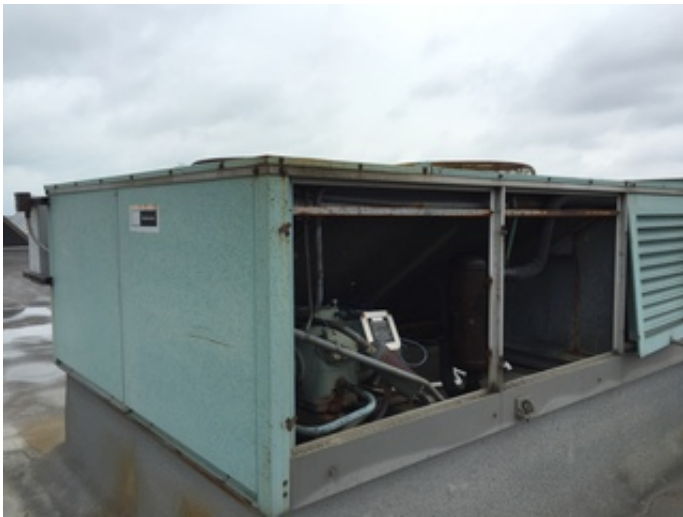
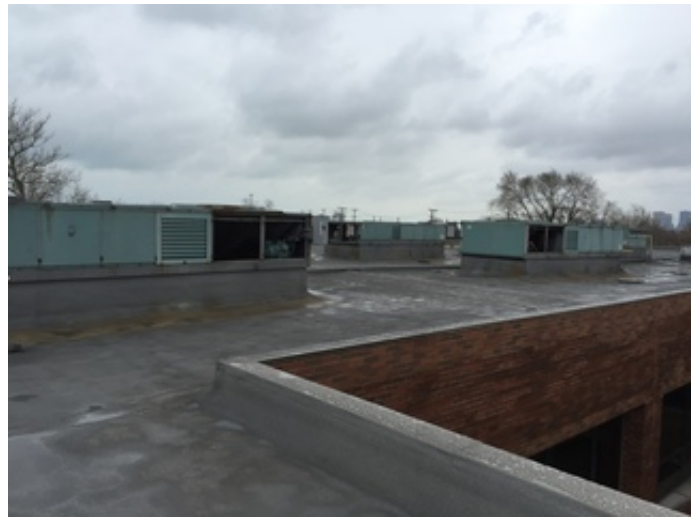
Rooftop Units

**Description:** The existing system for the overall facility consists of 8 gas fired, electric cooling rooftop units, 1977 original equipment, in poor condition. These units are multizone units and the corridors are used as the return plenum for all of the rooftop units. There are 2 gas fired heating only units serving the gym, 1977 original equipment, in poor condition. There is one gas fired, electric cooling rooftop unit serving the 2001 addition in fair condition. The staff indicates that some repair parts are no longer available for the 1977 equipment. The system does not provide the required CFM as per OBC Mechanical code standards. The system temperature controls are electric thermostats, but the DDC controls are no longer operational for the 1977 building. The 2001 addition DDC controls are operational. The structure is equipped with air conditioning for the overall facility. The ductwork does not have the capacity to supply air conditioning for current ventilation standards and there is no return ductwork from any of the classrooms. The system is not compliant with the OSDM requirements. According to school officials, the site does not contain underground fuel tanks.

**Rating:** 3 Needs Replacement

**Recommendations:** Provide a new overall heating ventilating and air conditioning system to achieve compliance with OBC and OSDM standards that provides air conditioning and ventilation for the building. A new ducted system is required facilitate efficient exchange of conditioned air. Provide new DDC temperature controls with the new system. The new ducted system will likely require architectural soffits to accommodate the installation of the ductwork.

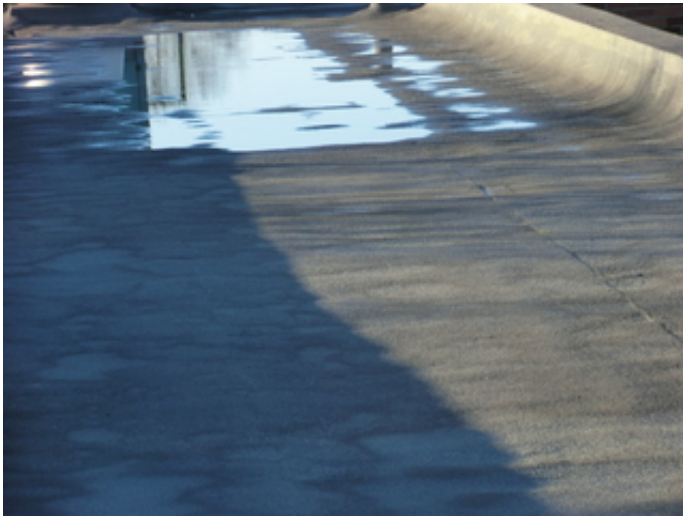
**Description:** Access to the roof is achieved via a hatch from a 3rd floor building services area. A sprayed applied roofing system was observed over the entire building. This system was applied approximately 5 years ago. The exact thickness of the foam system could not be determined. However, the silhouettes of all seams and joints of the underlying roof system were visible through the spray applied system. Additionally, the foam system is sprayed over the metal coping. However, the foam is not flexible and cracks are visible at nearly all of the joints in the coping. Ponding and deposits of displaced granules were observed as well.

Large ponds observed on the roof.

**Recommendations:** Remove both the sprayed applied system and the underlying roofing system. Provide a new membrane roof system over the entire building. Provide new roof insulation as the existing insulation is not specified to align with current energy standards. Provide new drains and metal coping as a part of roof replacement.

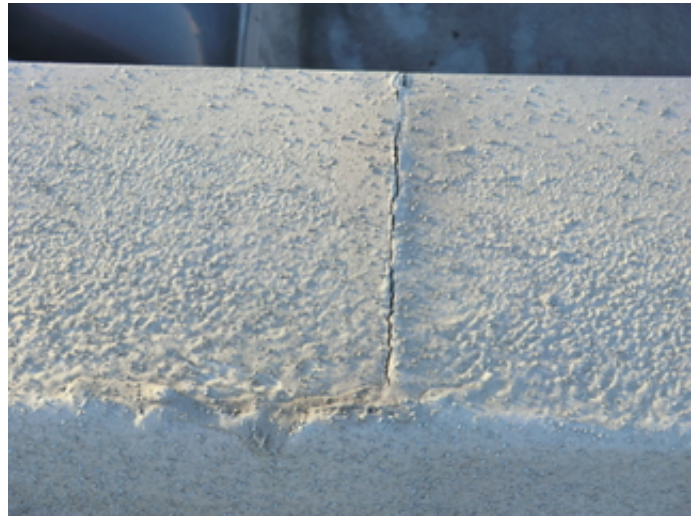
Roofing material cracked at coping joints.

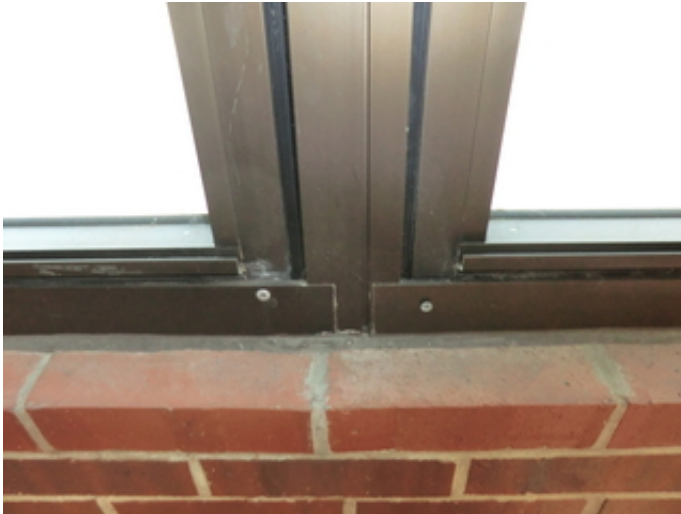
**Description:** Single pane, non-thermally isolated, bronze colored aluminum windows are present around the building. Most are fixed. However, every classroom has at least one operable awning window unit. The windows are original to the building and evidence of condensation was observed on the interior surface of the aluminum. A large skylight systems is present along the east leg of the building. During episodes of wind-driven rain, the vents are blown open and water freely enters the building.

This window offers little to no thermal performance..

**Recommendations:** Provide new thermally insulated windows throughout the buildings with integral means of managing natural light levels. Replace the skylights with a translucent panel system.

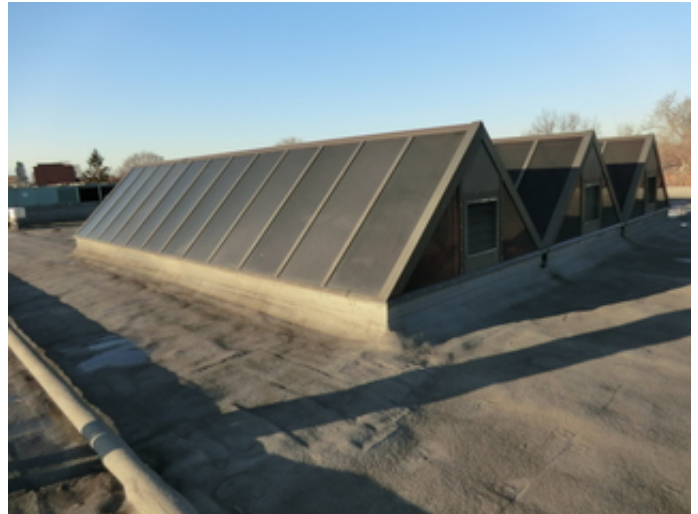
Skylights are vulnerable to water penetration.

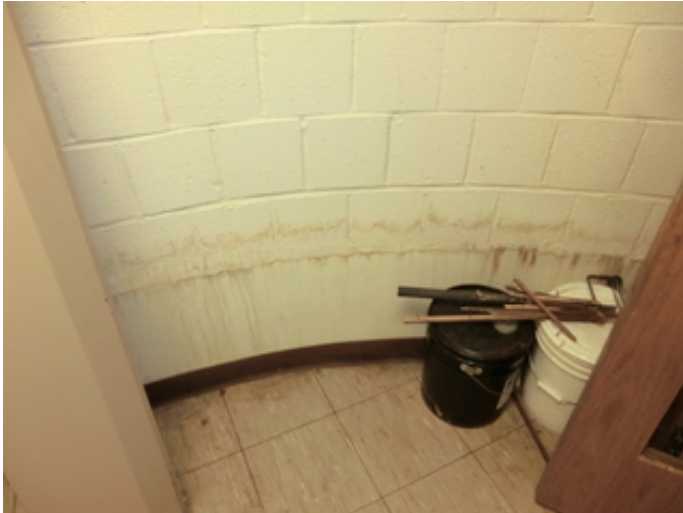
Description: The foundation was observable in very limited areas. The northwest stair well is the only one which extends below grade. Some water penetration was observed in the radius wall at the transition from block to concrete. A small below grade janitor's room appears to be free of water penetration or foundational movement. No indications of foundational movement were observed anywhere in the building.

Evidence of water penetration

Recommendations: Provide a membrane to prevent further moisture penetration in the below grade areas of the building.

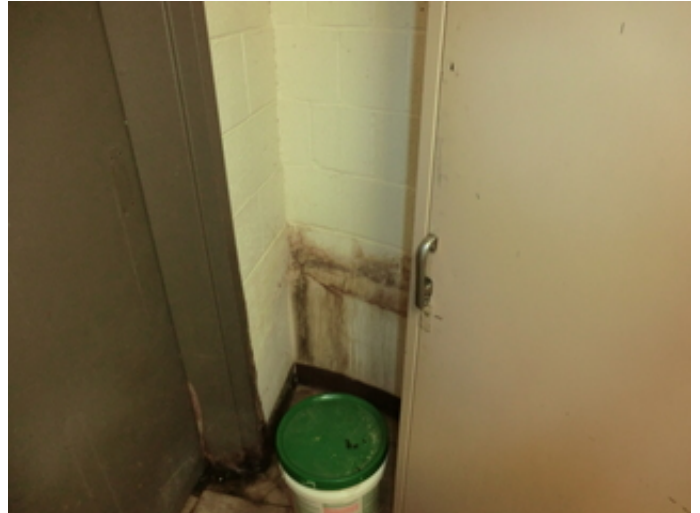
Evidence of water penetration.

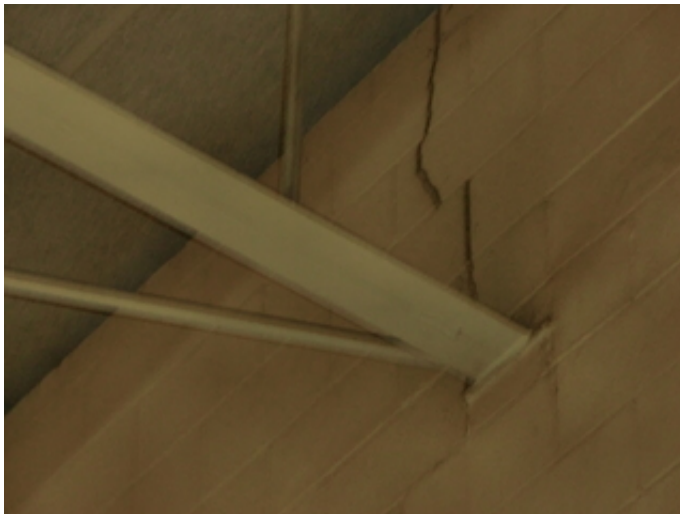
**Description:** Numerous instances of vertically running cracks were observed below and above the joist seats in the load bearing walls of the gymnasium. Though the walls were constructed with control joints several cracks occurred at load bearing points. Expansion joints were observed in the exterior brick veneer around the building. It appears as though control joints have been added as a part of exterior masonry repairs. Additionally, some spalled brick units were observed around the building exterior. Control joints appear to be properly located both inside and outside of the building. However, the sealing material is damaged or missing on many of the interior joints.

Cracks in wall above joist bearing.

**Recommendations:** Obtain a detailed structural analysis of the gymnasium load bearing walls and make repairs accordingly. Patch and repair areas of spalled and cracked brick. Provide cleaning and sealing for the exterior masonry surfaces as well. Provide new caulk at interior control joints.

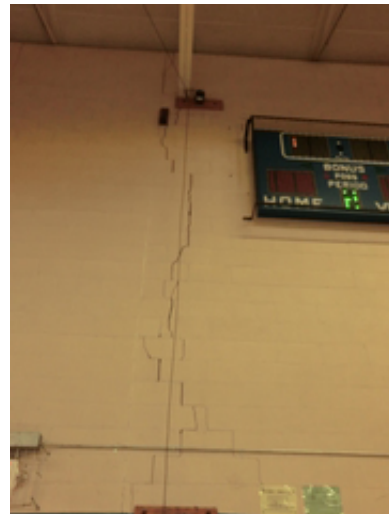
Cracks in wall below joist bearing.

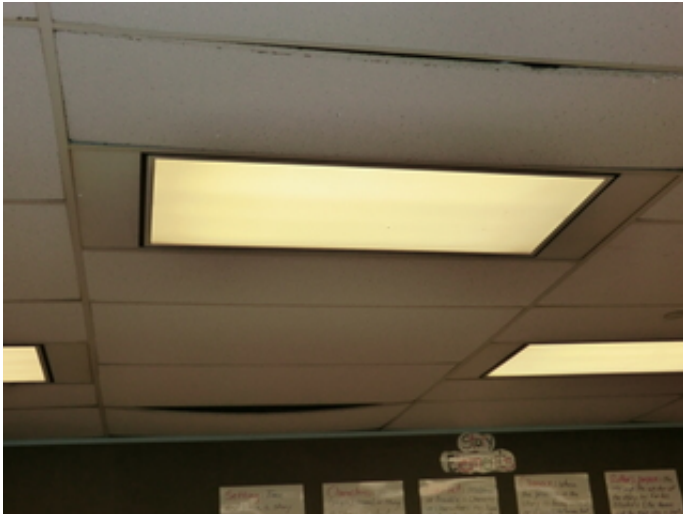
Ceiling tiles are sagging and falling away from the grid.

**Recommendations:** Given that; - Ceilings will be replaced for life safety upgrades - Floors are past their useful life - Casework is non-existent or inadequate in nearly all classrooms - Painting has not occurred recently All finishes should be replaced throughout the building.

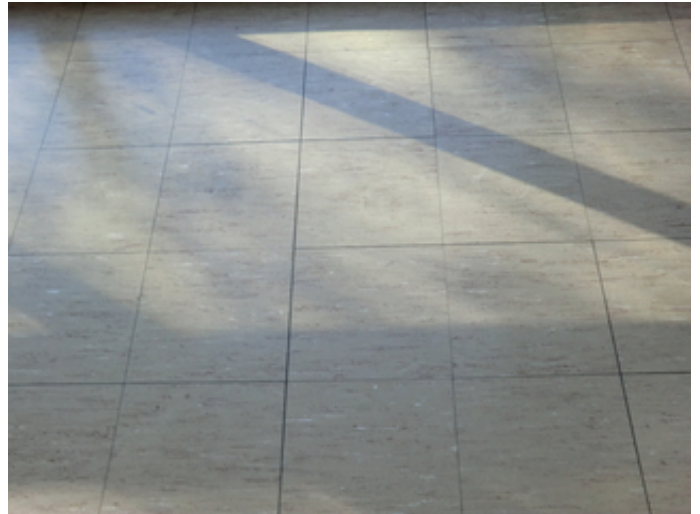
Floor tiles are separating at the joints.

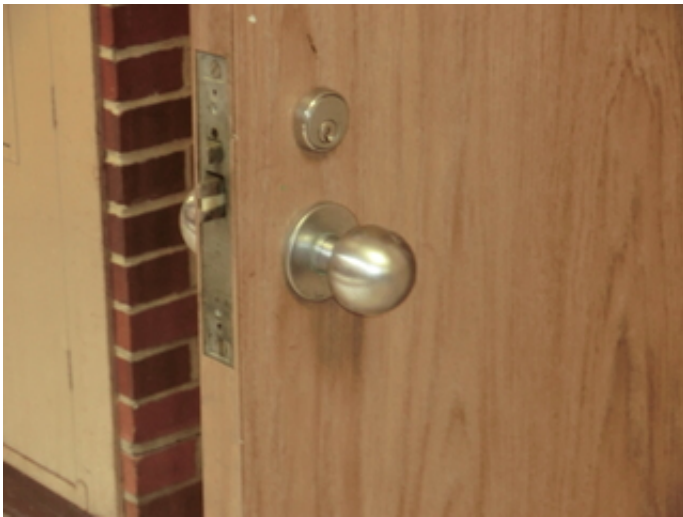
Door hardware is not ADA compliant.

Recommendations: Provide the following: - Wheelchair lift to gym platform - ADA lever type hardware - ADA compliant high contrast signage with braille print. - ADA door assist

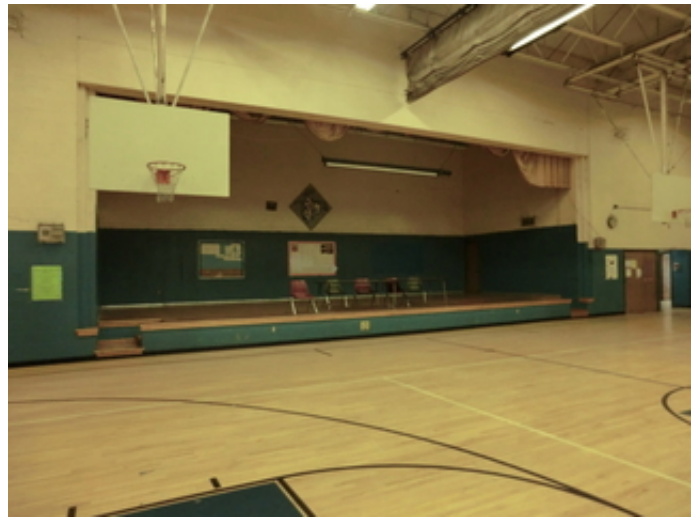
Wheelchair access is not provided to the platform.

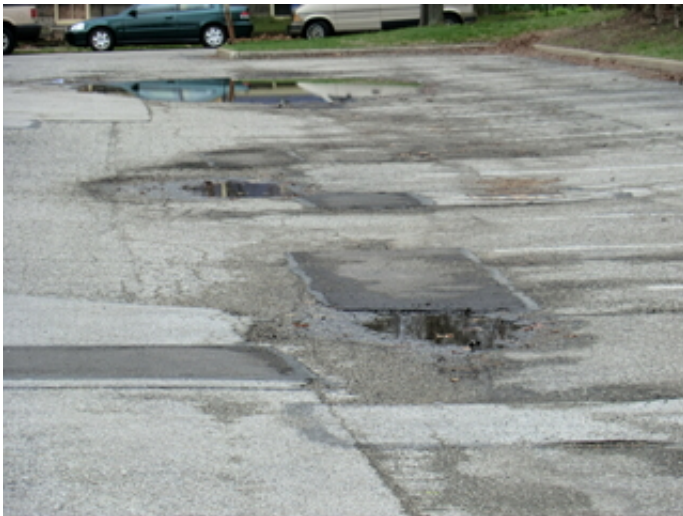
**Description:** The 5 acre site is circumscribed by public roads and sidewalks on all sides. Most paved parking areas are striped for around 60 spaces. However, satellite imagery reveals over 100 cars parked on paved areas. The OSDM recommended quantity of parking spaces for a school this size is 101. Most of the asphalt paved areas are in poor condition. Uneven surfaces, potholes and loose asphalt were observed. Playground equipment was observed to be in good condition and free from hazards. A blister adjacent to the street is provided for bus drop off. However, dedicated car drop-off is not provided. Sufficient paved pedestrian circulation surfaces are provided throughout the site. Some areas of the concrete in front of the main entrance have deteriorated over the years.

Deteriorated asphalt paving.

**Recommendations:** Repave all parking surfaces. Provide heavy duty paving between right of way and service areas. Replace loose and deteriorated concrete.

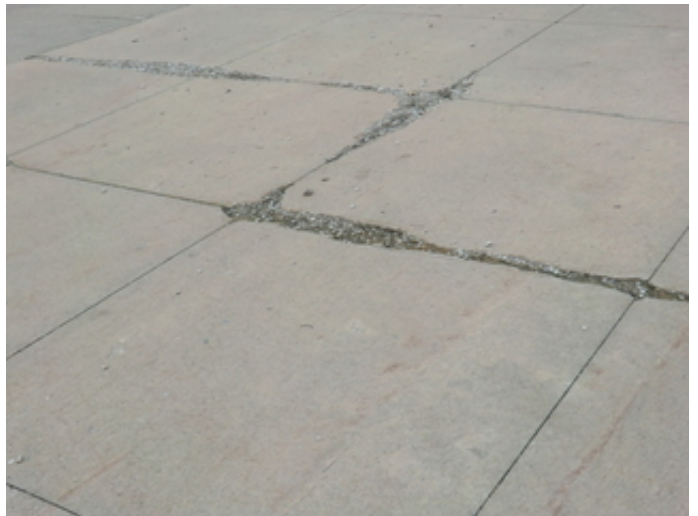
Deteriorated concrete paving.

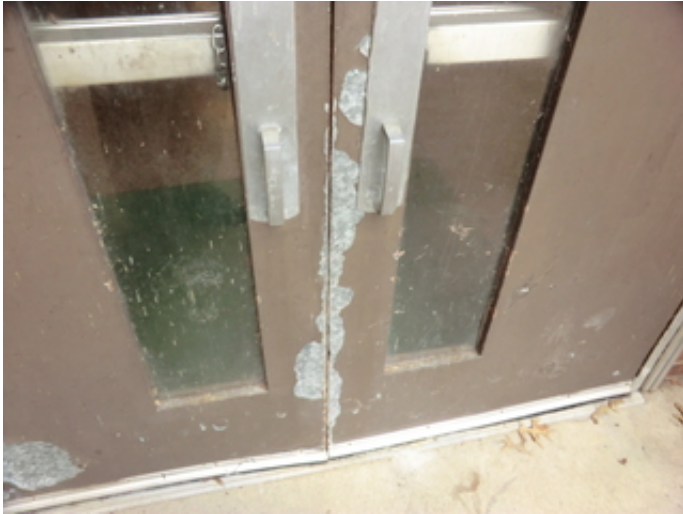
Description: Some of the exterior doors are original to the build while others are not. However all display varying extents of abuse, wear, misalignment, corrosion and other indications of deterioration. Many of the doors lack insulation and/or insulated glazing.

Misaligned corroding doors.

Recommendations: Replace each of the exterior doors throughout the building envelope.

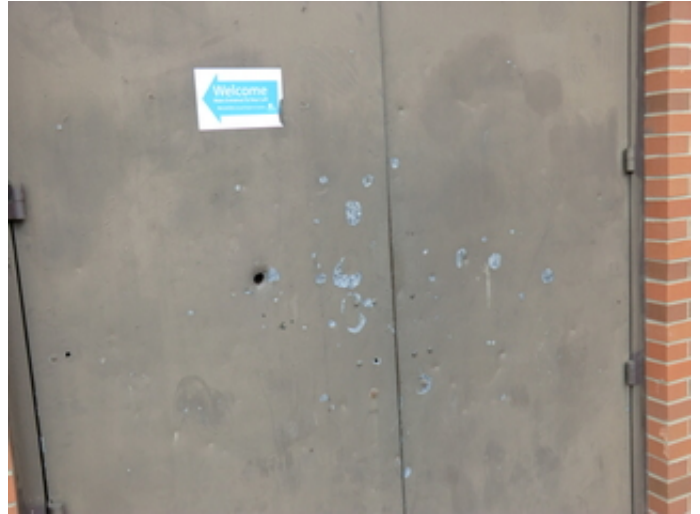
Damaged exit doors.

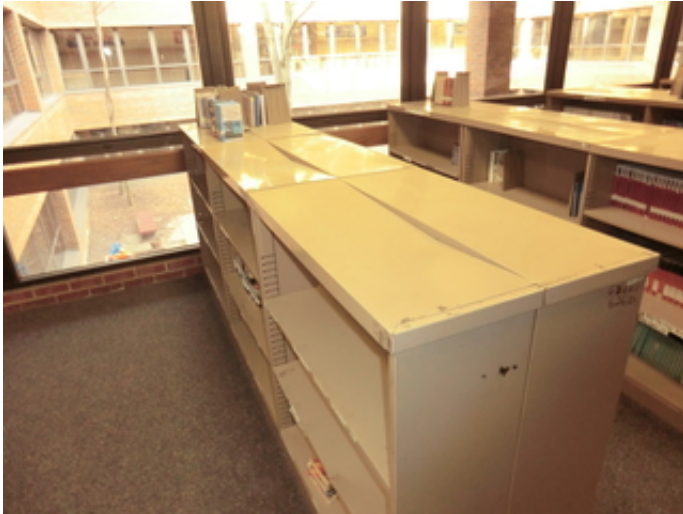
Description: The furnishings for students and instructors appear to be in excellent condition. Maintenance staff report that few repairs are needed. Metal shelving in the media center, however, is damaged and will likely continue to deteriorate with further use.

Dented media center shelving

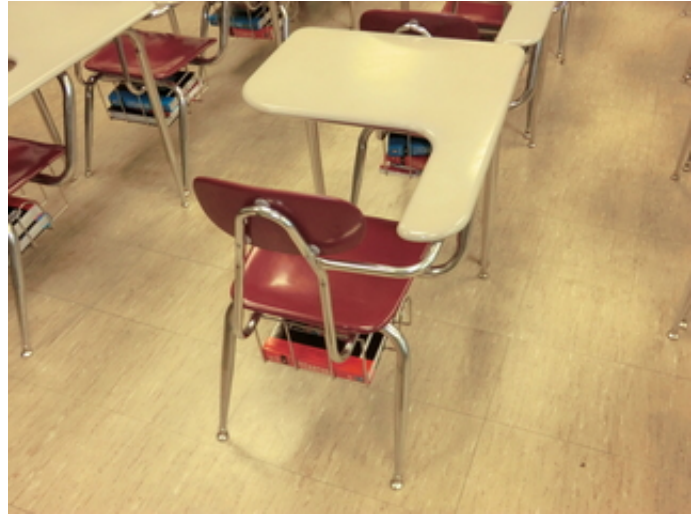
Most of the furniture is in good condition.
