INTRODUCTION

The Scope of Work for the Cleveland Metropolitan School District includes an Assessment Validation and Master Plan Option of the Lincoln-West High School Facility. The assessment was prepared in 2008 by the Ohio School Facilities Commission. This assessment and master plan options are based on a Program of Requirement for a projected enrollment of 950 students in grades 9-12. No career technical programs were considered.

Lincoln-West High School

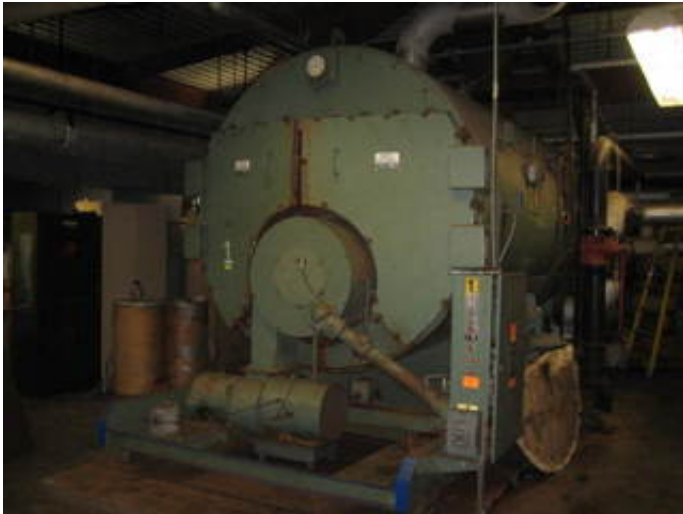
Natural gas fired boilers

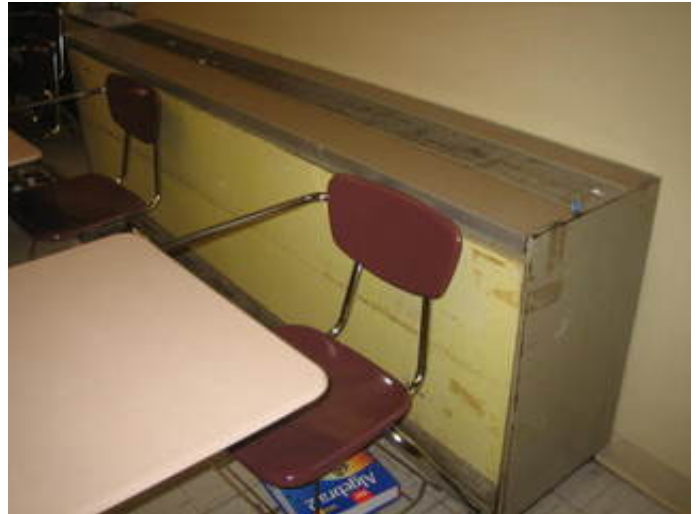
1970 Classroom unit ventilator

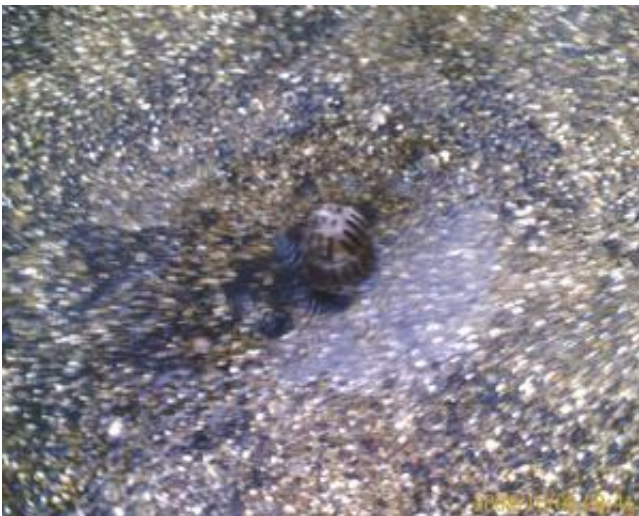
Typical roof drain condition

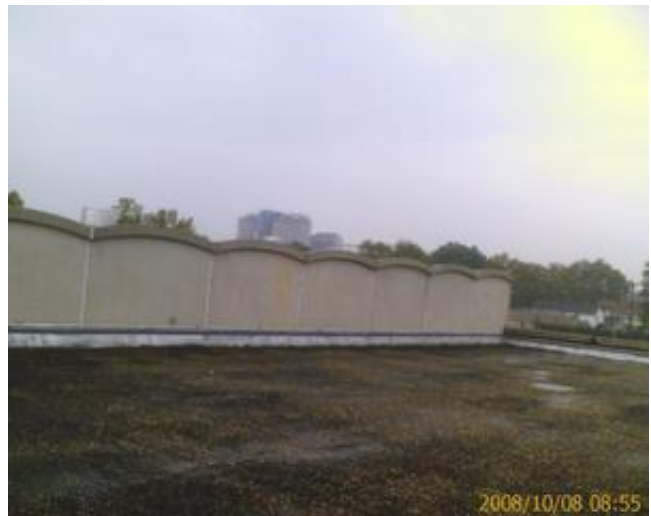
Typical roofing condition

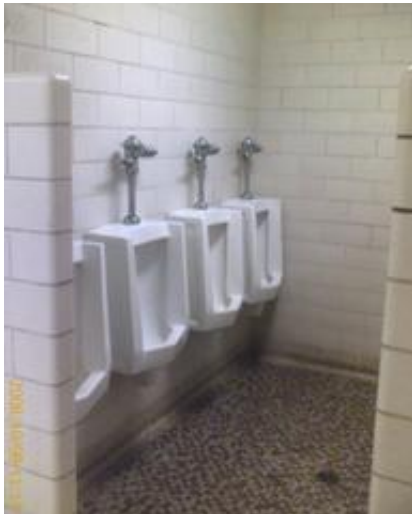
Typical urinal condition

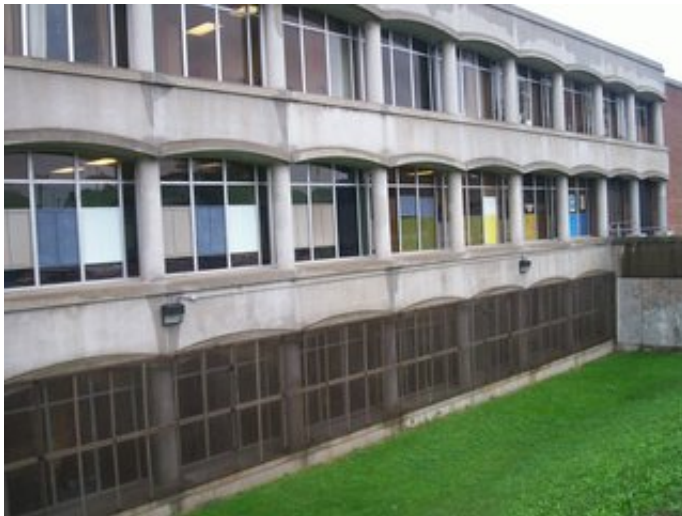
Windows at classrooms

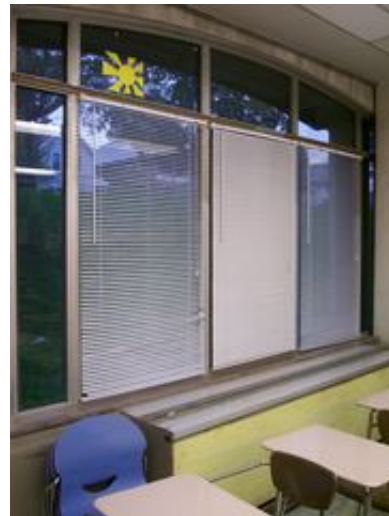
Typical window and screen in classroom

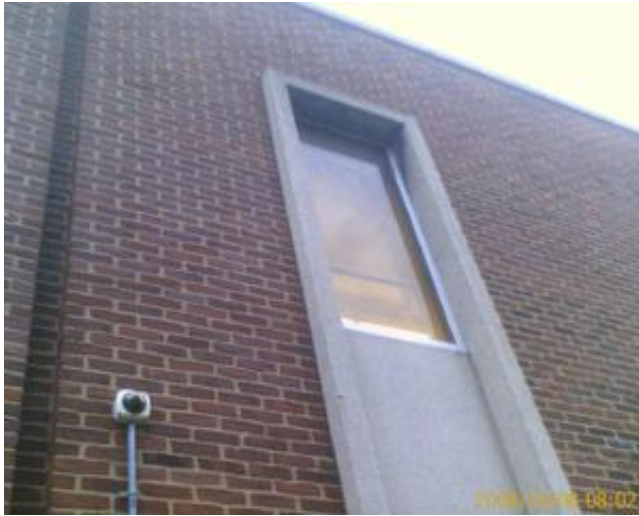
Typical lintel condition

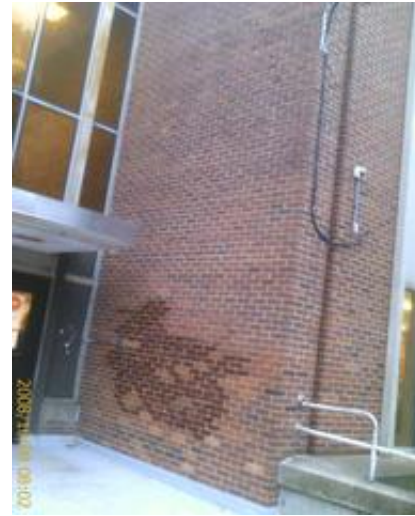
Typical exterior masonry condition

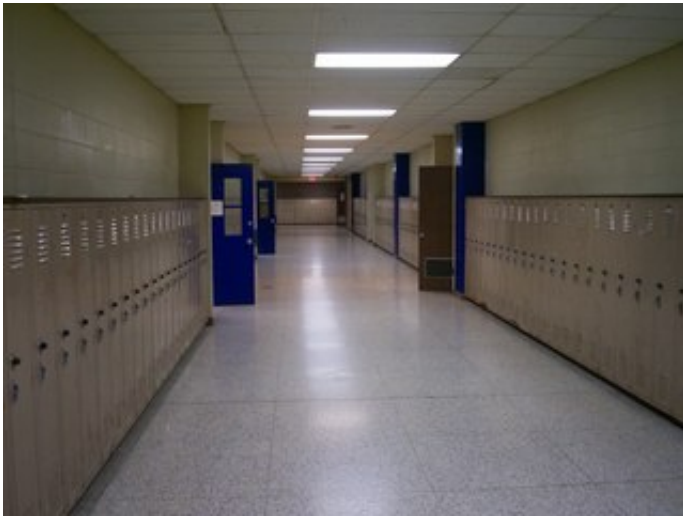
Typical corridor finishes

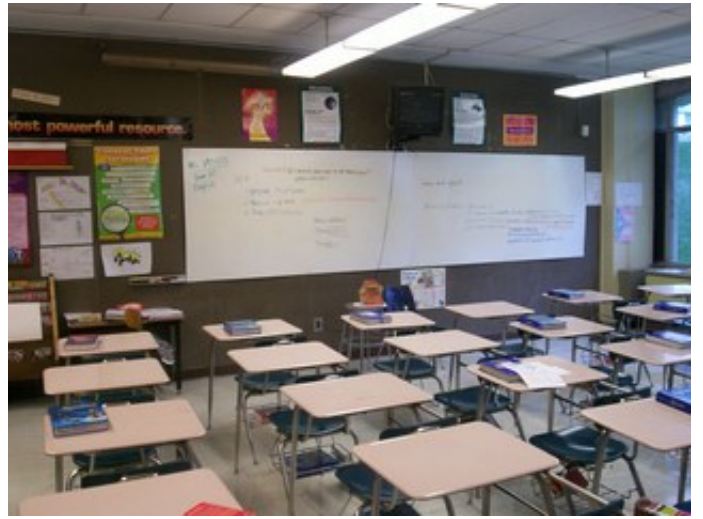
Typical classroom finishes

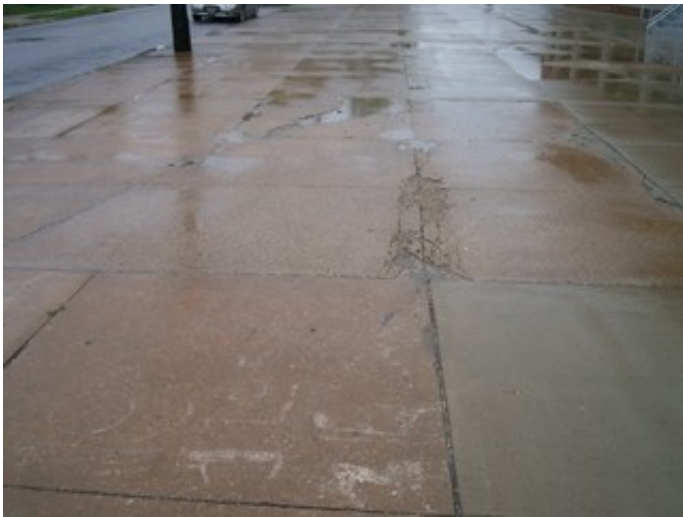
Concrete sidewalk in deteriorating condition

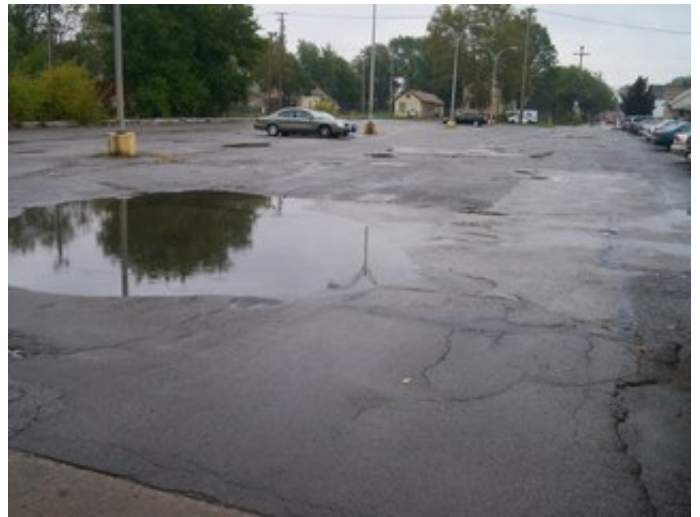
Ponding in asphalt parking lot in poor condition

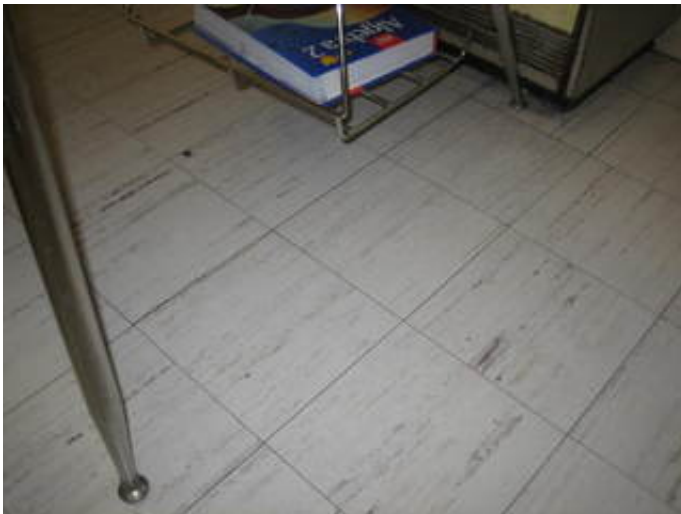
VAT flooring

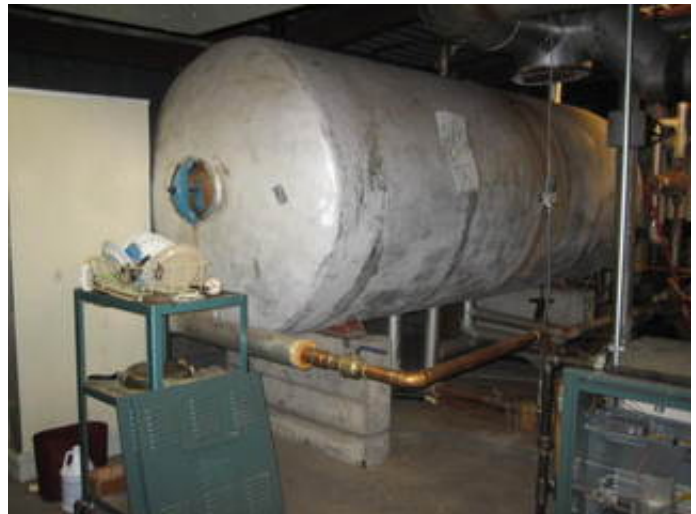
Hazardous materials

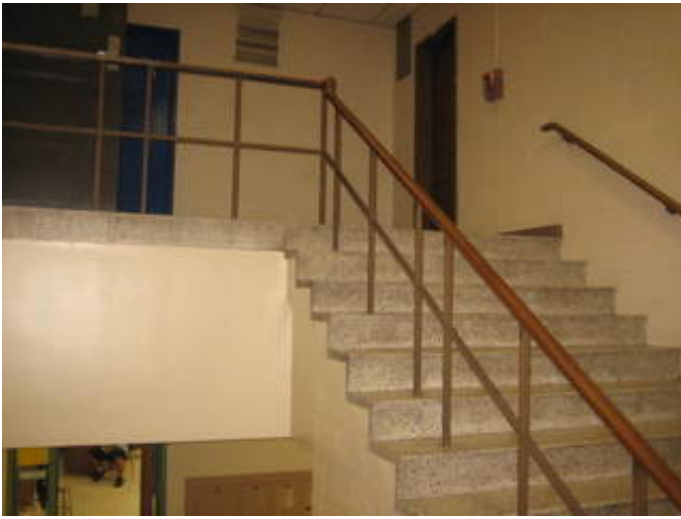
Open non-compliant stair
