FACILITIES COST ANALYSIS
May 2015

Michael R. White PK-8 School
for the
Cleveland Metropolitan School District
1111 Superior Ave. E, Suite 1800
Cleveland, Ohio 44114
Phone: (216) 838-0000

Architectural Vision Group, Ltd.
23850 Sperry Dr.
Westlake, Ohio 44145
Phone: (440) 808-8520
Fax: (440) 808-8301

Building Assessment – Michael White PK-8 School

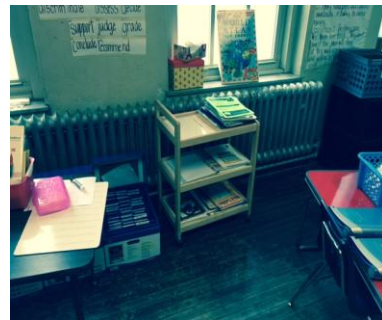
The existing heating system for the entire facility utilizes two (2), Weil McCane, gas-fired, steam boilers. Each boiler has an input of 4,100 MBH. These boilers are approximately ten (10) years old and in fair shape. It appears the steam piping throughout the facility is original (1921) and should be replaced. The facility is heated from steam radiators in each classroom, office and large-group areas. These radiators are original fixtures.

Steam radiators

Provide comprehensive, new heating, ventilating and air conditioning systems to achieve compliance with Ohio Building Code and Ohio School Design Manual standards. Provide new DDC type temperature control to meet both the OBC and OSDM requirements.

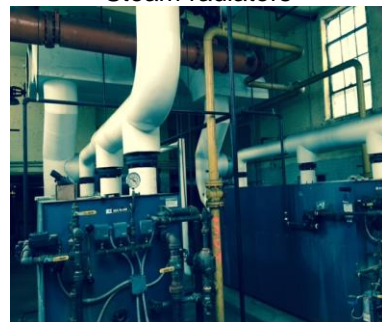
Steam boilers

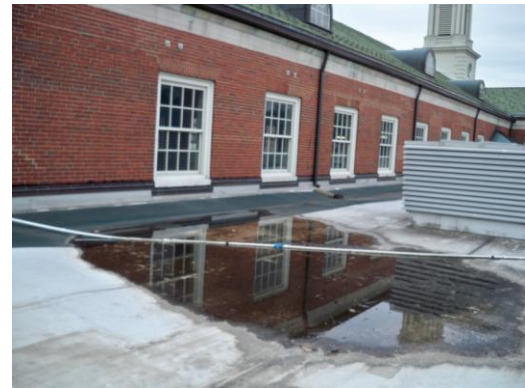
The school building has a combination of a clay tile type roof over the sloped roof structure and an EPDM system over the flat roofs. The clay tile appeared in fair condition, but some pieces were observed fallen off and it appears to be the original 1921 roof. According to Ohio School Facilities Commission data, the EPDM roof was installed in 1999 and, thus, requires replacement due to age. Ponding was observed in many locations of the flat roof. According to maintenance personnel, the roofs do not currently leak, but there is a broken roof drain pipe in the mechanical room which needs replacement. Signs of past water penetration were observed throughout the school during the physical assessment. The roof flashing does not wrap over the parapet walls, and evidence of water penetration through coping joints was observed. There is a roof hatch provided in the school, but it was suggested that easier access could be gained by crawling through a window. The sloped roofs utilize a system of gutters and downspouts for storm water that shed onto the lower flat roofs. Water is then drained via internal roof drains. Overflow is addressed by the means

Roof ponding

The flat, EPDM roofs require replacement to meet Ohio School Design Manual guidelines for the age of the system and due to ponding conditions – this also includes the boiler house roof and the greenhouse roof. The clay tile roof will need to be replaced, and due to Historic Preservation requirements, the new roof will likely be required to be clay tile, instead of shingles, which is what the OSFC will co-fund. The difference in cost will be the District’s responsibility. The original roof hatch in the original building should be replaced.

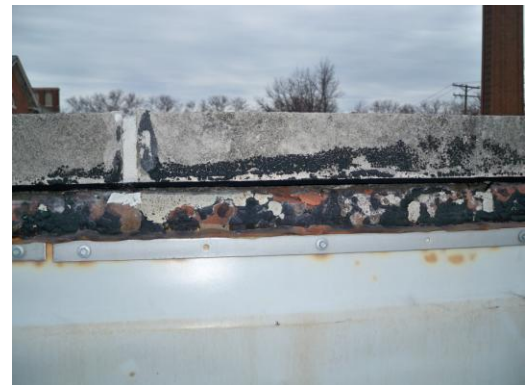
Parapet wall deterioration

Replacement of one internal roof drain, which is leaking in mechanical room, should be done. Metal capping over existing stone coping should be done to prevent further water penetration. Replacement of all gutters and downspouts should be done due to age and condition. New gutters and downspouts should be provided for the detached classroom building.

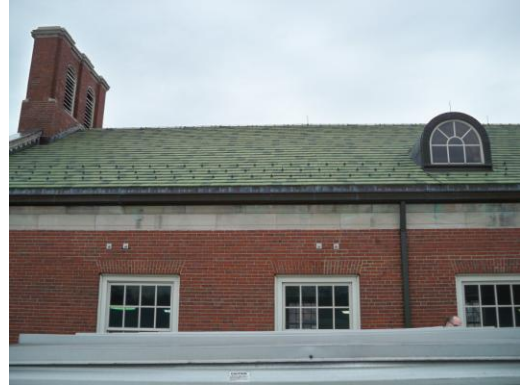
Clay tile roof

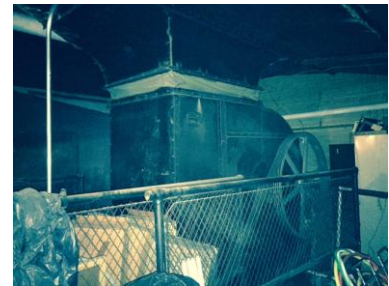
Ventilation of the facility is done thru two (2) large supply fans utilizing steam heating coils to heat the ventilation air. The fans and steam coils are original (1921) and in poor shape. The ventilation requirements of the OSDM and OMC are not met.

Fan Ventilation Unit with Steam Heating Coil

Provide an air conditioning system to meet OSFC design manual requirements. This will include a central boiler and chiller plant, and new exhaust throughout this facility. Pricing included in Item A.

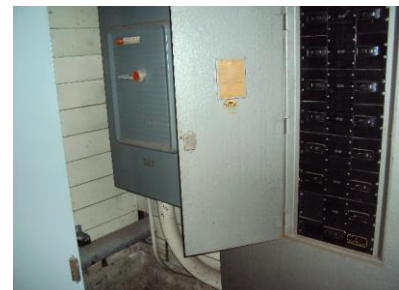
The electrical system provided to the overall facility is a 240-volt 1200-amp 3-phase 4-wire system with an updated Main Distribution Panel installation (date unknown) and is in fair condition.

The entire electrical system requires replacement to meet Ohio School Design Manual guidelines for overall capacity and lack of OSDM required features. Adequate outlets should be provided throughout the building to meet OSDM requirements.

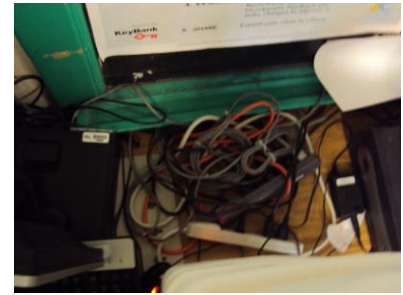
Adequate outlets are not provided throughout the building for cleaning and services. The typical classroom contains approximately two (2) outlets. This creates the use of extension cords throughout the rooms and above ceilings. This is in violation of building codes. The overall building has lighting protection safeguards in place.

Excessive use of extension cords

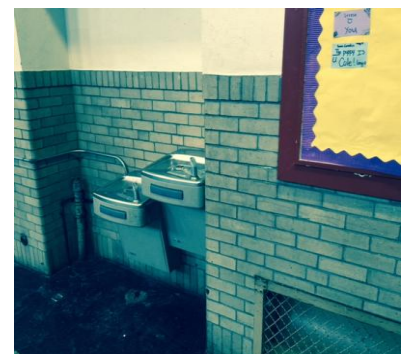
High / Low electric water coolers

Provide for replacement of water closets, urinals and lavatories as noted below. Replace two (2) domestic water heaters (main facility and greenhouse) and the domestic supply piping and sanitary piping should be replaced due to age. All drinking fountains and electric water coolers should be replaced due to age.

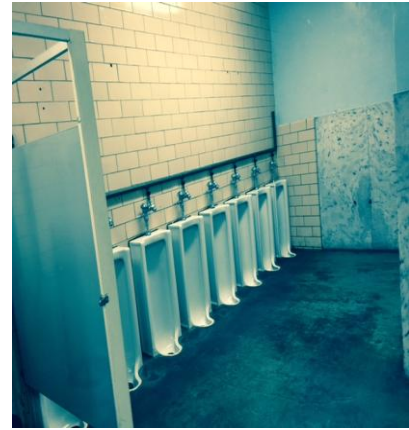
Boy's Restroom

education restroom. The boys' group restrooms consist of: nine (9) floor-mounted water closets, 16 floor-mounted urinals and five (5) wall-hung lavatories and they are in poor condition. The girls' group restrooms consist of 24 floor-mounted water closets, and eight (8) wall-hung lavatories and they are in poor condition. The staff restrooms and special education restroom consists of: nine (9) floor-mounted water closets, and eight (8) wall hung lavatories. All fixtures are in poor shape and should be replaced. The facility contains three (3) high/low electric water coolers, one (1) single electric water cooler and one drinking fountain, all of which are in poor condition.

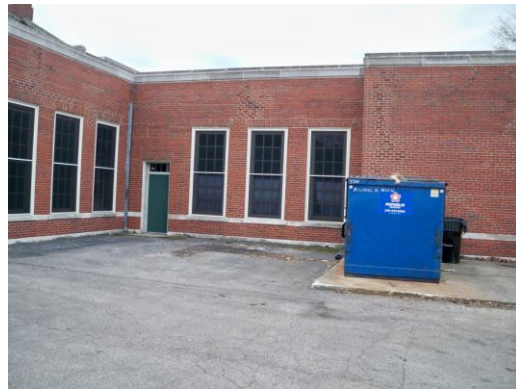
Typical Windows

The windows throughout the majority of the school facility are an aluminum frame type window system with single glazing. They are not an approved OSFC window system. The windows are a double-hung type. Most are provided with insect screens, but many of the screens were observed in damaged condition. The window system hardware appears in good condition. Their date of installation is not known, but they appear to be less than 15-20 years old. Some windows are equipped with curtains, however, most have no window treatment. No glass block windows were observed in the school. The school is reported to contain skylights that have been roofed over according to maintenance personnel. There are no curtain wall window systems in the building. The windows in the boiler house and the greenhouse are steel frame, single pane windows that are a major source of energy loss. The windows on the boiler house feature security grills that are rusted and in poor condition. The greenhouse windows feature operable vents and are not equipped with screens. The top portion of the greenhouse windows are a frosted type glass. The exterior doors in the school building have recently been replaced with double-pane transoms and sidelights and they appear in good condition.

Provide a new window system in the original building due to these windows being a non-OSDM compliant window system. Provide for replacement of the greenhouse, detached classroom building and boiler house windows due to age, condition, and being a non-OSDM compliant type window system. New compliant window systems should be a double-glazed, thermally separated frame type with integral blinds.

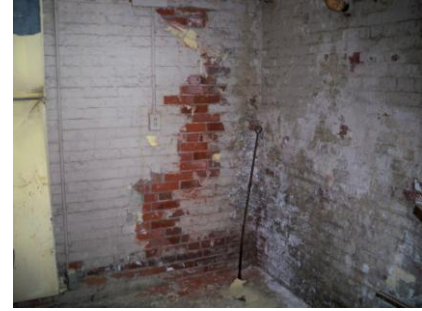
The facility is equipped with concrete foundation walls on concrete footings that were observed to be generally in fair condition. Areas of water penetration were observed in the basement. No grading or site drainage deficiencies were noted around the perimeter of the structure that are contributing to or could contribute to foundation/wall structural deterioration.

Provide for waterproofing and foundation repairs/sealing with foundation drainage system in the basement.

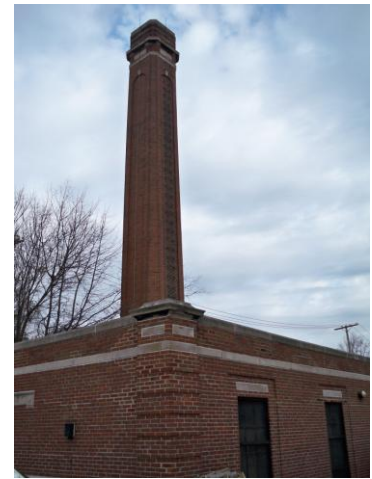
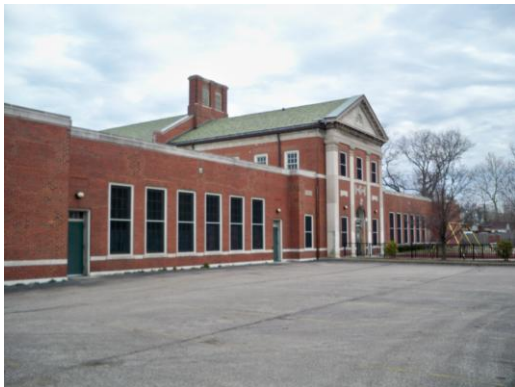
Michael R. White School and the boiler house are both brick veneer structures on load bearing masonry wall system which displayed some locations of deterioration and are in fair condition. The exterior masonry is not provided with control joints. Brick veneer masonry walls are not cavity walls. Exterior masonry does not appear to have been cleaned or sealed in recent years and shows evidence of mortar deterioration. No locations of mold were observed. Architectural exterior accent materials consist of stone banding, columns and detailing which is aesthetically pleasing and generally in good condition, with a few exceptions. Nearly all the classrooms have plaster walls which are generally in poor condition, are deteriorating and contain asbestos (according to the EEHA Report by OSFC). Other interior walls include

Brick requires cleaning and sealing

Provide tuckpointing in all areas of mortar deterioration as required. Provide for exterior masonry cleaning, sealing and caulking as required. Repoint stone and brick window sills where required. Provide an allowance for limestone repairs where it is damaged to ensure weathertightness of the building envelope. Replace steel lintels in boiler house. Provide new exterior skin for the greenhouse building for both added insulation value and protection from water penetration.

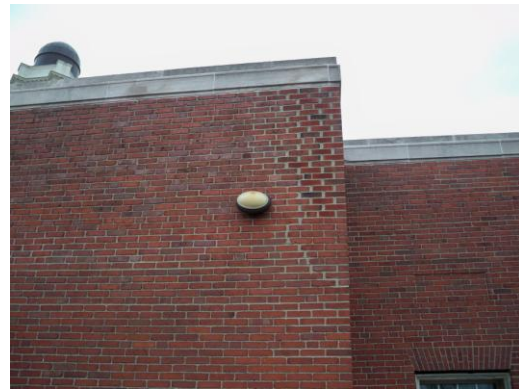
Previous repairs

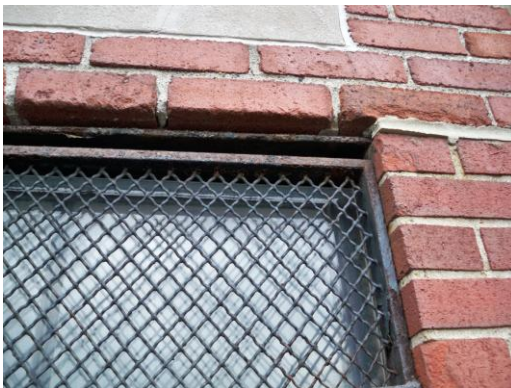
Delaminating Lintels at Boiler House

Tuckpointing: 1,020 SF x \$5.25/ SF =	\$5,355.00
Exterior masonry cleaning: 3,061 SF x \$1.50/SF =	\$4,591.50
Exterior masonry sealing: 3,061 SF x \$1.00 / SF =	\$3,061.00
Lintel Replacement: 53 LF x \$250/LF =	\$13,250.00
Caulking: 250 LF x \$5.50 / LF =	<u>\$1,375.00</u>

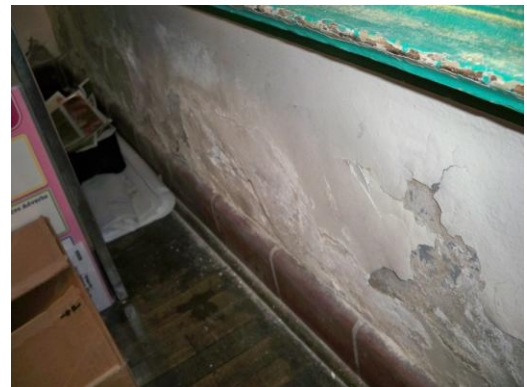
The school features conventionally partitioned classrooms, with worn out wood flooring, plaster walls which are spalling and damaged, and a mixture of plaster ceilings and dropped 2' x 4' lay-in ceilings that range in condition from fair to poor. According to the Enhanced Environmental Assessment conducted by the Ohio School Facilities Commission in 2008, the plaster walls and ceilings contain asbestos and will require removal and replacement. Some rooms throughout the building feature VAT flooring which is in poor condition. The typical classroom features a cloakroom with hooks and shelving for student storage, and very little built in storage for teacher materials. What is present is the original, old wood casework and it is in poor condition. The typical classroom features more than an adequate amount of chalkboards that are the old wood, built-in the wall type and no tack boards are installed. The interior classroom doors are non-recessed, original wood units. They are equipped with knob type hardware with some featuring wired glass vision panels and all are in poor condition.

Damaged plaster

Provide complete replacement of finishes and provide new casework due to very poor conditions and due to the installation of systems outlined in this report (such as HVAC system, electrical, technology, etc). Provide for replacement of old toilet partitions and provide new accessories. Plaster walls and ceilings will require replacement due to asbestos and condition.

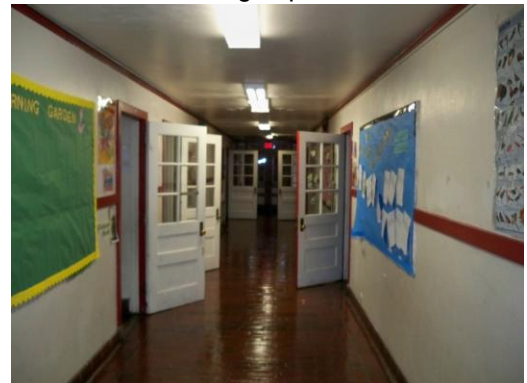
Corridor finishes

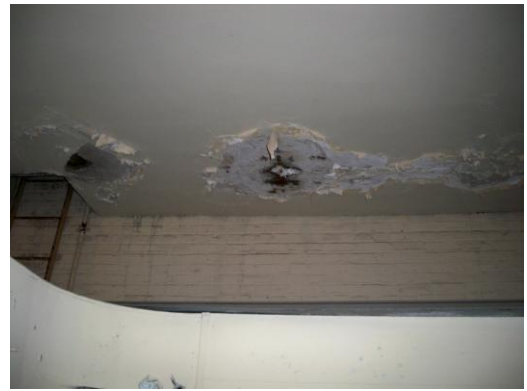
Plaster damage in ceiling

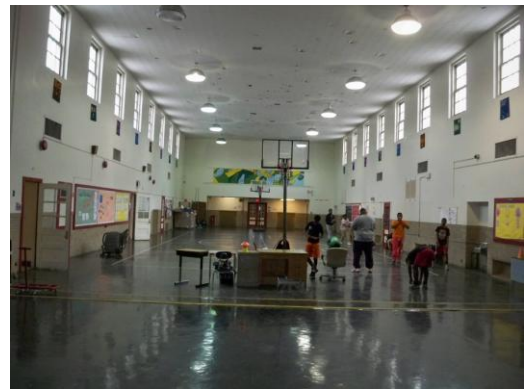
The central portion of the school is a large, open space that houses multiple purposes. It serves as the auditorium in the central portion, gymnasium space at each end, and one end also serves as the cafeteria. Seating is moved to the side areas when not in use. This space features a painted concrete floor which is uneven, plaster walls and 1' x 1' ceiling tiles glued to the plaster ceiling. They are falling off and in poor condition. No bleachers, auditorium seating or basketball backboards are provided. Portable basketball hoops are used. A stage is present for the auditorium and features old wood flooring. A small balcony is provided for the auditorium, but is completely full of tables and chairs as it is used for storage. There are two manual partition doors provided in this central space to separate the gyms/cafeteria from the auditorium. The doors go from floor to ceiling in height and they appear to be the original 1921 doors. They are reported as inoperable.

Center portion – 2 gyms and an auditorium/cafeteria

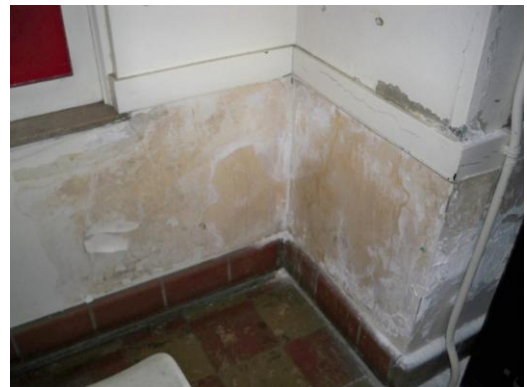
Plaster Damage

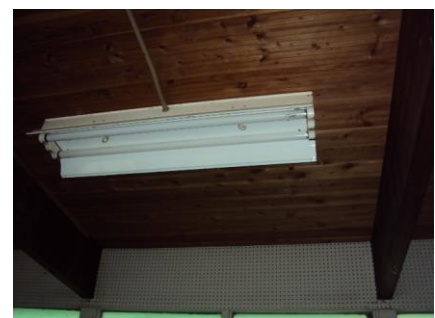
The typical corridors in the building are equipped with T-8 1' x 4' surface fixtures in fair condition providing inadequate

Typical Gymnasium Lighting fixture

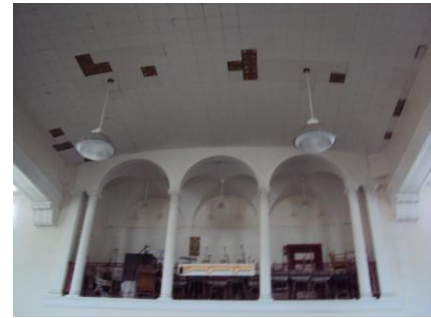
illumination. Typical classrooms are equipped with T-8 surface mounted fixtures in fair condition thus providing inadequate illumination. There also is a lack of dual level switching in some areas. The gymnasium/cafeteria/auditorium area is equipped with metal halide high bay fixtures in fair condition providing inadequate illumination. The kitchen area is equipped with surface mounted wrap around fluorescent fixtures in fair condition providing inadequate lighting levels as per code.

Typical Gymnasium Lighting fixture

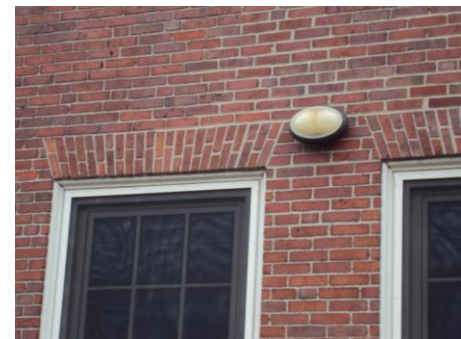
Typical exterior building mounted fixture

The exterior site lighting system is equipped with surface mounted incandescent fixtures in poor condition. Pedestrian walkways are illuminated using municipal owned street lights. Parking areas are not illuminated other than with spillover light

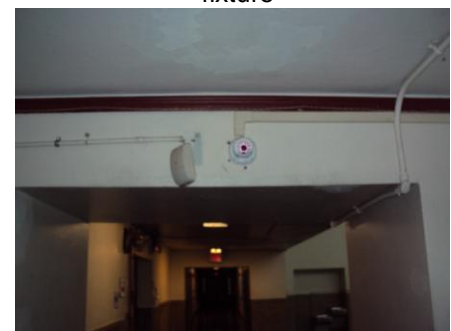
The overall facility contains a CCTV intrusion type security system that is in good condition. An automatic visitor control system is not provided. Non-compliant CCTV cameras are provided at main entry areas and main corridors. CCTV is monitored at an off-site Administrative Area. A compliant computer controlled access control system integrating alarms and video signals with appropriate UPS backup is not provided. The system is not equipped with card/biometric readers. The security system is inadequate and the system is not fully compliant with Ohio School Design Manual guidelines.

Typical motion sensor & corridor camera

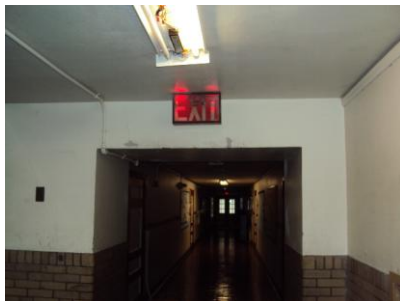
The overall school facility, greenhouse building and boiler house building are equipped with an emergency egress lighting system consisting of non-compliant red lettered plastic constructed illuminated exits signs. The system is in fair condition. The facility is equipped with emergency egress floodlighting, but it is not adequately provided throughout the building.

Non-compliant exit sign

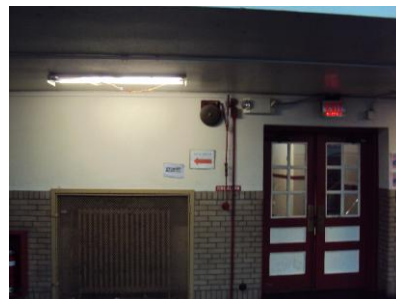
Non-compliant exit sign

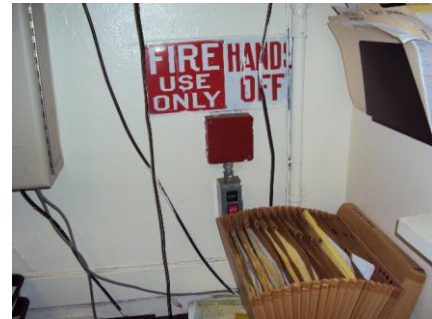
Fire alarm activation in office

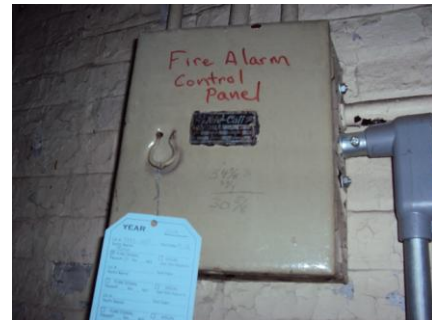
The greenhouse building is currently not connected to the fire alarm system. The boiler house building is connected to the existing outdated fire alarm system of the main school building.

Fire alarm panel

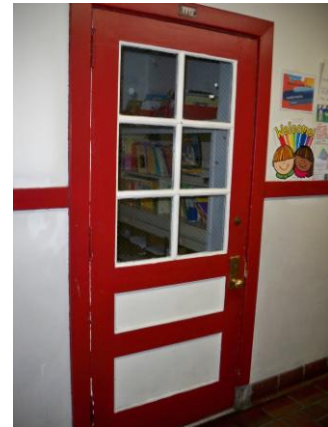
On the interior of the building, space allowances and reach ranges are compromised. There is not an accessible route between floor levels of this 2-story building. There are three separate upper levels in the building that are not connected – requiring an elevator at each location for accessibility. Access to the stage is not facilitated by a lift or ramp. Interior doors are old wood units, are not recessed and are not provided with ADA compliant hardware. The large group restrooms are not equipped with ADA compliant toilets or sinks. The floor mounted urinals are ADA compliant but in poor condition requiring replacement with new fixtures, including provisions for the disabled. Toilet partitions are old units and do not provide appropriate ADA clearances. Mirrors generally do not meet ADA requirements for mounting heights and they are in poor condition. ADA compliant electric water coolers were observed, but are in dated condition. The health clinic restroom is not compliant with ADA requirements. ADA signage is not provided.

Old wood doors without ADA hardware

Provide ADA-compliant signage, new elevators, sinks, toilets, urinals, electric water coolers (see Item E), toilet partitions, mirrors and toilet partition accessories as required. Replace old wood doors with new leafs equipped with ADA hardware. Provide lift for the stage. Parking issues are corrected in Item P.

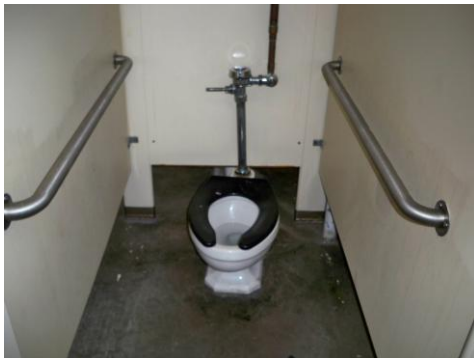
Non ADA Compliant restroom

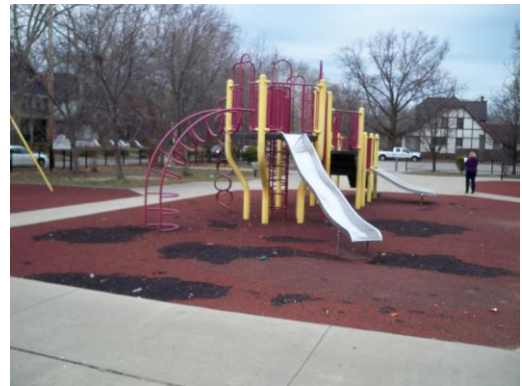
Rubber surface deteriorated

The playground equipment is metal and in generally good condition. The playground is located on a rubber surface that is in poor condition. Hard surface playgrounds used to be located in the north parking lot and are now abandoned. This area is used strictly for parking. Several areas on the site have chain link fencing which is in poor condition. There are no athletic facilities on the site.

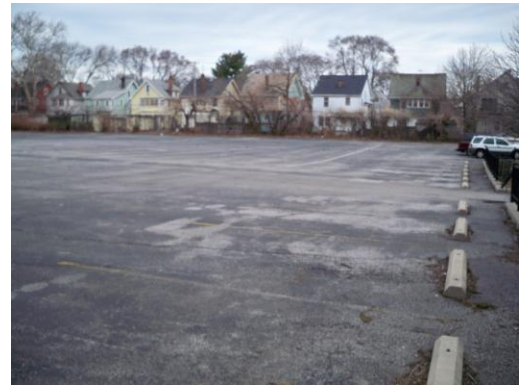
According to the building principal, only special needs students are provided with busing to the school and the buses park curbside on the street. There is no auto drop-off loop provided. Staff and visitor parking occur in two main parking asphalt lots that are in poor condition. Parking spaces appear to be adequate in terms of quantity. No ADA parking spaces were observed.

Parking lot in poor condition

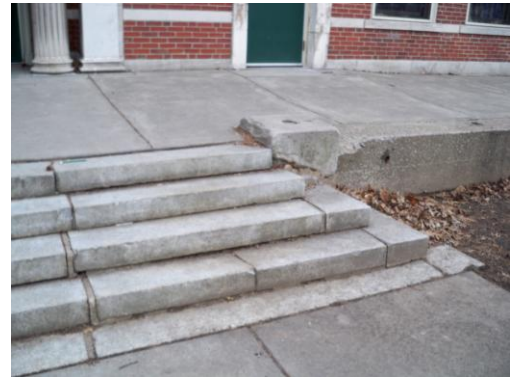
Concrete deterioration & missing railing

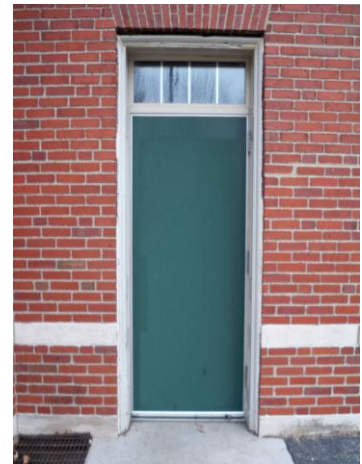
The typical hollow metal, exterior doors appear to have been recently replaced, and are generally in good condition with the exception of two (2) leafs. The doors have been installed on the old wood jambs and are showing signs of deterioration. They should be replaced. The interior vestibule doors however, have not been replaced and are old wood units. There are no overhead doors in the facility. In the boiler house there is one (1) old exterior door that is in poor condition and requires replacement and another four (4) exterior doors in the greenhouse require replacement.

Typical exterior door

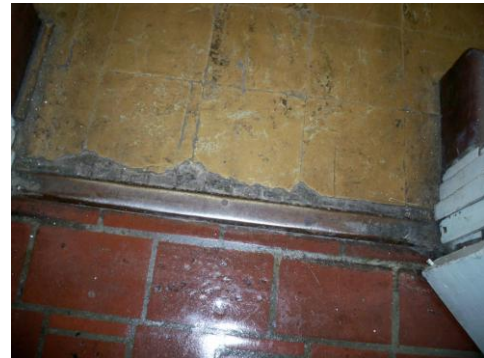
In 2002, the OSFC conducted an Enhanced Environmental Hazardous Assessment to determine the presence of asbestos and other hazardous material. The study concluded that there is asbestos in the pipe insulation, pipe fittings, flexible duct connection, hard plaster and vinyl floor tiles which will require removal/abatement. New walls and ceilings will be required (see Section J). Costs are allocated for lead-based paint testing and mockups, as well as for incineration of fluorescent lamps and ballasts. It is assumed that the paint throughout the building is lead based due to the building's construction date and will be required to meet the EPA's Renovation/Replacement programs guidelines.

Damaged VAT flooring

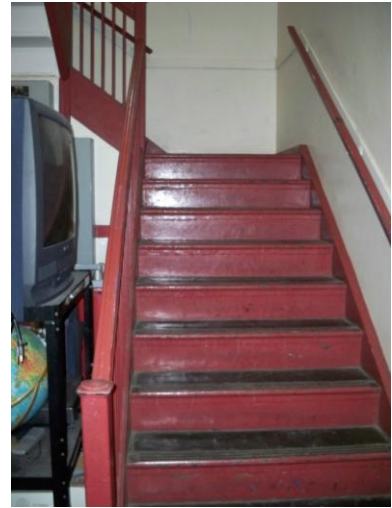
The school facility and the greenhouse do not contain an automated fire suppression system. There are no kitchen hoods or equipment requiring kitchen hoods. The facility is not currently equipped with an emergency generator. Exit corridors are situated such that dead-end corridors are not present. The facility features four (4) main stairwells that are not protected by two-hour fire enclosures. The facility does not have any exterior stairways from intermediate floors. Guardrails/handrails are not compliant with current Ohio Building Code. Fire extinguishers are provided throughout the facility. Rooms with a capacity greater than 50 occupants are equipped with adequate egress.

Non-compliant stair/handrail

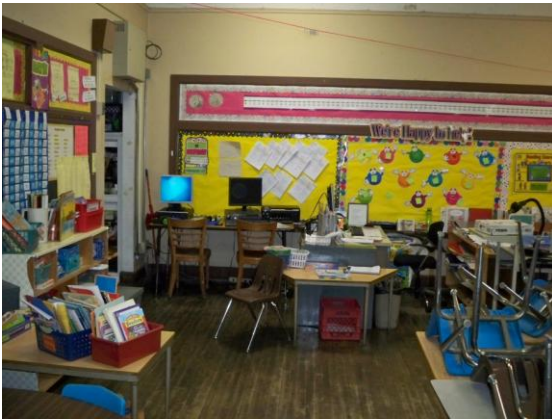
The typical furniture is generally mismatched, dated and in worn condition. It consists of student desks and chairs, teacher desks and chairs, desk-height file cabinets, reading tables/computer workstations and bookcases.

Mismatched and dated furniture

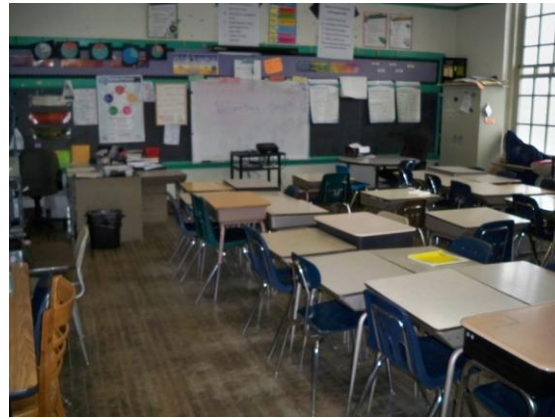
Mismatched and dated furniture
