FACILITIES COST ANALYSIS
May 2015

Tremont Montessori PK-8 School
for the
Cleveland Metropolitan School District
1111 Superior Ave. E, Suite 1800
Cleveland, Ohio 44114
Phone: (216) 838-0000

Building Assessment and Cost Analysis for

Tremont Montessori PK-8 School

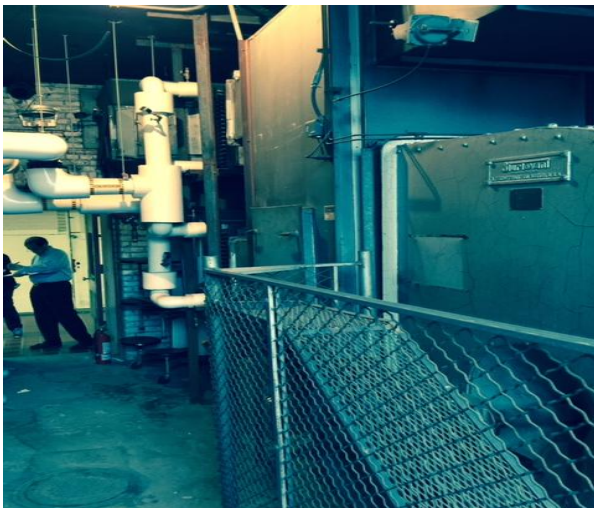
The existing system for the entire facility consists of three large fan units that also utilize a hot water coil for providing heat and ventilation to the school. These units appear to be 50+ years old and should be replaced. The hot water is provided from three (3) – Burnham Hot Water Boilers, each with 4,713 MBH input, 3,770 MBH output. These boilers are in fair shape and assuming they are 20-25 years old, they are approaching the end of their useful life and also should be replaced.

Fan Unit with Heating Coil

Provide a new overall heating, ventilating and air conditioning system to achieve compliance with Ohio Building Code and OSDM standards. Convert to a ducted system with all required vertical and horizontal chases. Provide new DDC temperature controls to meet both the OBC and OSDM. (This is included in the HVAC system replacement cost).

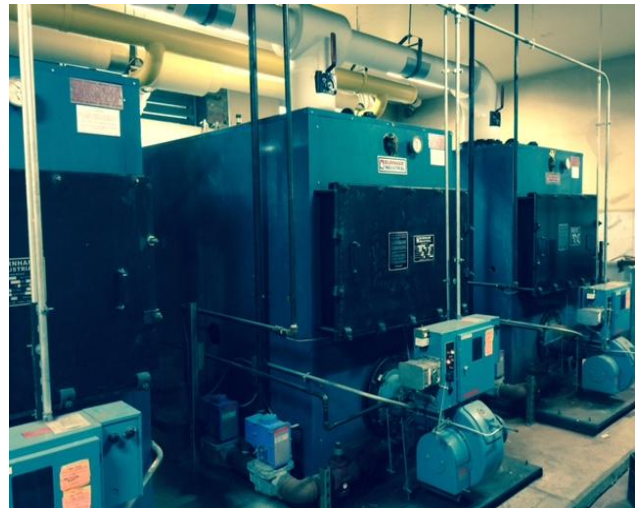
3 Boilers

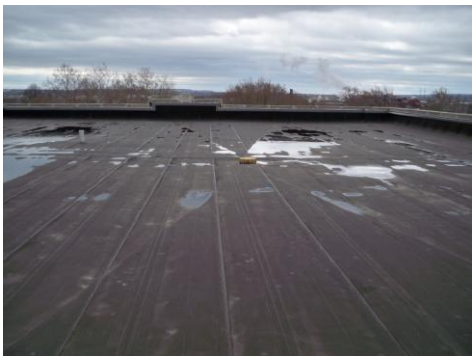
Minor ponding

The school has a flat, single-ply membrane roof system, which is reported to have been installed in 2001 and is in fair condition. There were no reports of current leaking, though signs of past leaking were observed inside the building. The roof has exceeded the age requirements by the OSFC, and will require replacement. Access was gained via two roof ladders which lead to roof access doors. They are in poor condition. The roofs utilize a system of internal roof drains and scuppers for evacuation of storm water and appear in fair condition. Minor areas of ponding were observed on the roof during the physical assessment. The parapet walls are equipped with stone coping, which have deteriorating joints leading to water penetration within the walls. There is no covered walkway attached to this structure.

The roof requires replacement to meet Ohio School Design Manual (OSDM) guidelines for the age of system. It is recommended that two roof ladders and roof access doors be replaced due to poor condition. Metal coping should be installed over existing stone coping to prevent further water penetration.

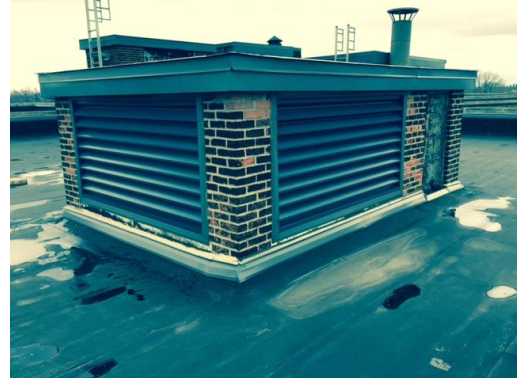
The ventilation fans utilize O.A. intakes and shafts that appear to provide adequate volumes of outside air, however, the system is not capable of providing this air as required by the OSDM and OMC. The relief for these units occurs through door louvers and large relief shafts extending through each floor.

Rooftop gravity vent

Provide an air conditioning system to meet the OMC and OSDM. This will include a new central boiler and chiller plant. Pricing included in Item A. Replace all general building exhaust fans. Pricing included in Item A.

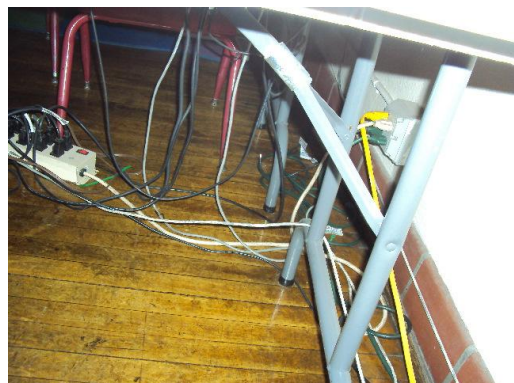
Excessive use of extension cords

Adequate outlets are not provided throughout the building for academic or cleaning services. The typical classroom contains approximately two (2) outlets. This creates an over-reliance on and an abundance of extension cords throughout the classroom ceiling areas. This is in violation of building codes. Also, the use of multi-outlet covers is used to supplement the lack of outlets. The overall building has lightning protection safeguards in place.

The entire electrical system requires replacement to meet Ohio School Design Manual guidelines for overall capacity and lack of OSDM required features. Adequate outlets should be provided throughout the building to meet OSDM requirements.

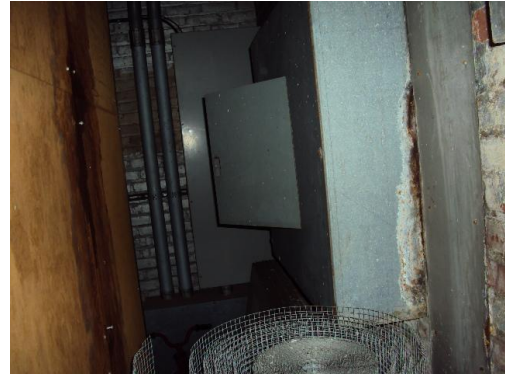
Main Electrical Room

The electrical system provided to the overall facility is a 240-volt 800-amp 3-phase 4-wire system with an updated Main Distribution Panel. Its installation date is unknown and it is in fair condition.

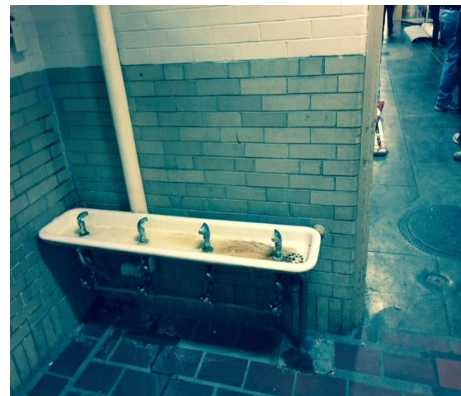
Water fountain

Provide all new fixtures (lavatories, urinals, water closets) due to age and condition. Provide all new electric water coolers and water fountains. Provide new back-flow preventer. Replace domestic water heater. Note: All fixtures required to be ADA complaint are accounted for in Item O.

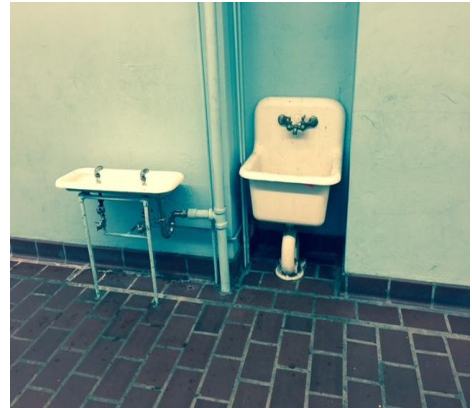
Water fountain & mop sink

The facility is equipped with no (0) ADA and four (4) non-ADA drinking fountains, as well as no (0) ADA and nine (9) non-ADA electric water coolers, all of which are in poor condition. Adequate exterior wall hydrants are not provided.

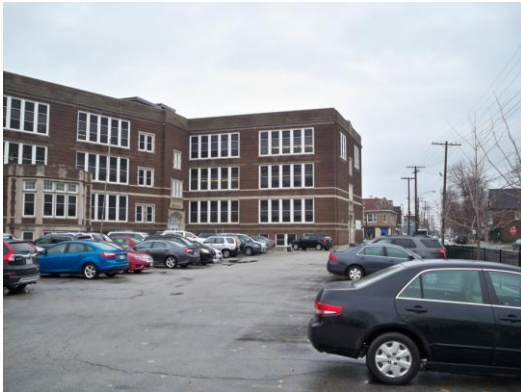
Windows are insulated

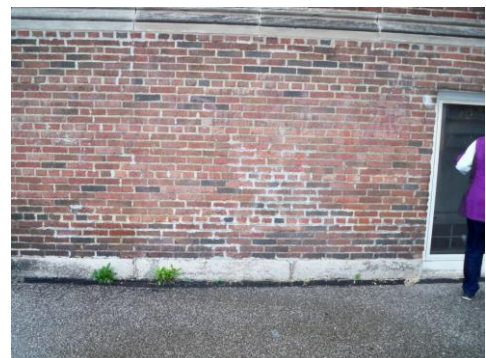
The overall facility has concrete foundation walls on concrete footings which displayed no significant locations of differential settlement, cracking or leaking. No significant issues in relation to foundation spalling were encountered. No grading or site drainage deficiencies were noted around the perimeter of the structure.

Concrete foundation walls in fair condition

Existing conditions require no renovation or replacement at the present time.

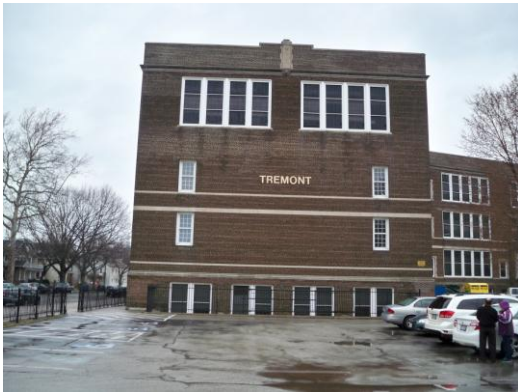
The overall facility has a brick veneer on load bearing masonry walls and a reinforced concrete frame type system. The facade displayed many locations of deterioration. Tuckpointing of mortar is required throughout. It appears that the top portion of the brick walls have been completely replaced around the roof perimeter. The exterior masonry does not have control joints, or adequate expansion joints. However, there does not appear to be any required as there is no indication of significant exterior masonry cracking or separation. Brick veneer masonry walls are not cavity walls. Weep holes are provided. The exterior masonry does not show signs of recent cleaning or sealing which is needed.

Brick requires cleaning, sealing & tuckpointing

Provide tuckpointing, cleaning and sealing of exterior brick masonry. Re-pointing of stone window sills is required. Provide an allowance for minor stone masonry repairs at entrances and parapets.

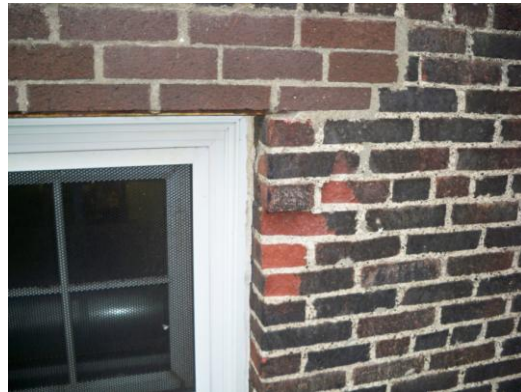
Lintels are beginning to rust

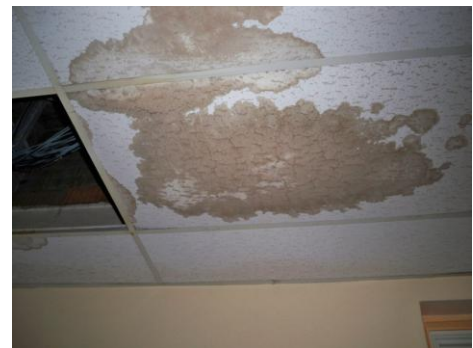
Damaged ceiling tiles

Provide replacement of toilet partitions and their accessories. Provide an allowance for plaster repairs in the walls and ceilings. Funding for replacement of interior doors is provided in Item O, including doors here noted as being in poor condition. Provide an art kiln and exhaust system. For a school funded by the Ohio School Facilities Commission, the building will be required to meet LEED Silver Certification. Because the building lacks wall insulation, furring out of existing exterior walls and providing insulation and abuse resistant GWB will be required in order to achieve credits for energy savings. To correct the separation of the kitchen and the cafeteria, an addition is proposed to accommodate those spaces. Convert existing auditorium/cafeteria into a gymnasium by providing bleachers in the gym for the middle school population, replace wood flooring and provide basketball backboards. Provide for lightweight concrete infill in all classrooms with wood flooring to support the new VCT flooring finish. Provide for replacement of the wood flooring on stage.

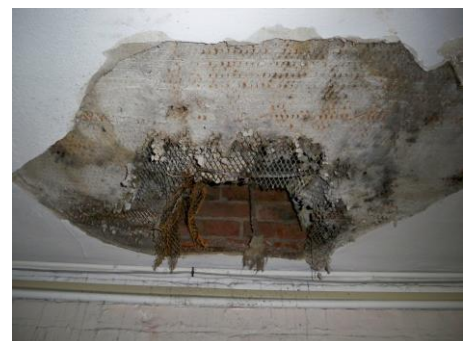
Damaged plaster ceiling

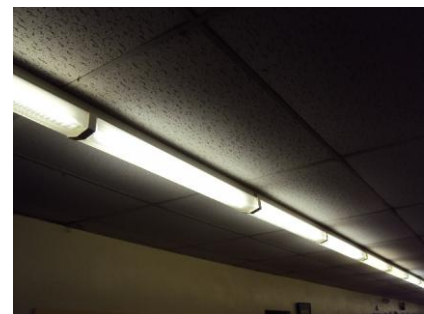
The typical corridors in the building are equipped with T-8 strip fixtures with an acrylic lens in fair condition providing inadequate illumination. Typical classrooms are equipped with T-8 surface mounted fixtures in fair condition, providing inadequate

Typical corridor lighting fixture

Provide complete replacement of lighting system due to lighting levels, condition and lack of multilevel switching.

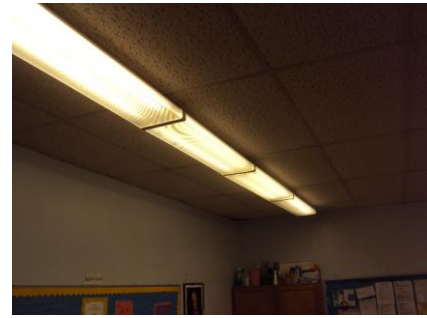
Typical classroom lighting fixture

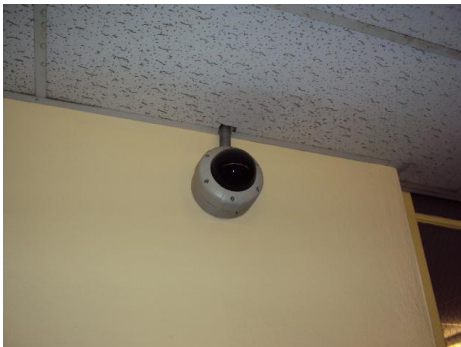
The overall facility contains a CCTV intrusion type security system in fair condition. An automatic visitor control system is provided. Non-compliant CCTV cameras are provided at main entry areas, and main Corridors. CCTV is monitored at an off-site Administrative Area. A compliant computer controlled access control system integrating alarms and video signals, with appropriate UPS backup, is not provided. The system is not equipped with card/biometric readers. The security system is inadequate throughout the building and is not fully compliant with Ohio School Design Manual guidelines.

Corridor security camera

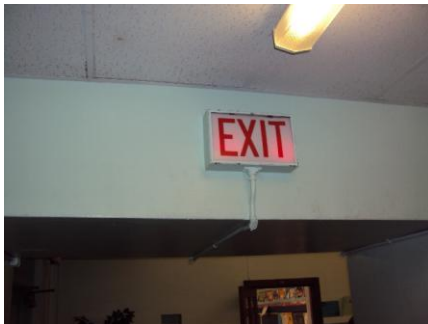
The overall facility is equipped with an emergency egress lighting system consisting of non-compliant red-lettered plastic construction illuminated exits signs, and the system is in fair condition. The facility is equipped with emergency egress floodlighting, but is not adequately provided throughout the building.

Non-compliant exit sign

Provide complete replacement of emergency/egress lighting system to meet Ohio School Design Manual and Ohio Building Code guidelines. Although funding for emergency/egress lighting is not shown for the unusable basement and other areas, work is considered mandatory and funding will be provided via a Life Safety Allowance in master planning.

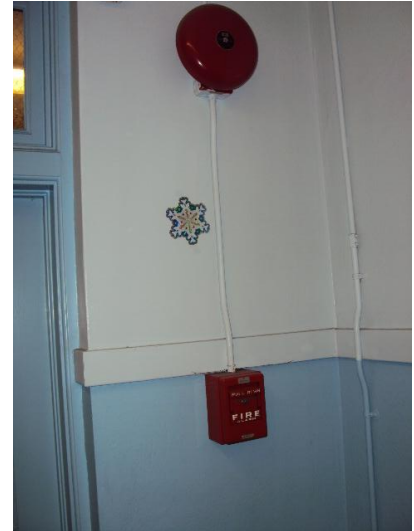
The overall facility is equipped with a Simplex fire alarm system. Its installation date is unknown and it is in poor condition. The system consists of manual pull stations and bells as

Typical pull station and indicating bell

Provide complete replacement of fire alarm system to meet OBC, NFPA, and Ohio School Design Manual guidelines.

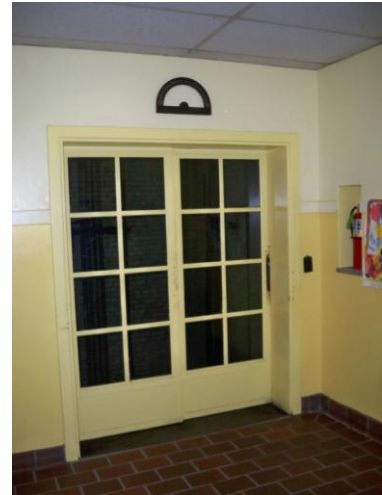
Freight elevator

Provide ADA-compliant signage, new elevator, ADA sinks, toilets, urinals, electric water coolers (see Item E for electric water coolers), new restroom mirrors, toilet partitions and other accessories as required. Replace old wood doors with new leafs equipped with ADA hardware. Provide a power door assist at entrance with ramp. Provide a lift for the stage, as well as at each set of steps leading to the two (2) gymnasiums.

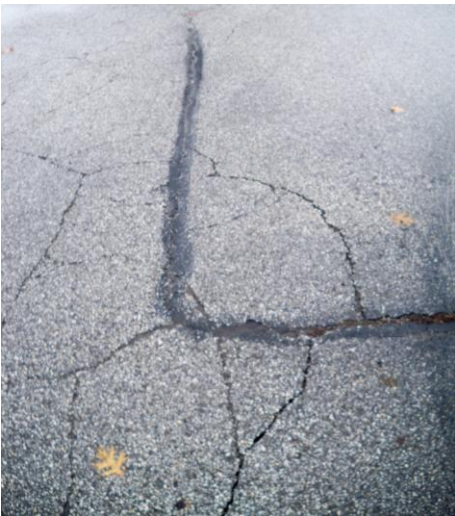
school based on 500 students, which is the target enrollment for this school. The asphalt parking lot is riddled with cracks and requires resurfacing.

Cracked asphalt

Redesign of parking lot circulation patterns: Lump Sum =	\$50,000.00
Pre-K playground:	\$55,000.00
Resurface asphalt: 3,861 s.y. x \$19.00/s.y. =	\$73,359.00
Concrete sidewalk replacement: 2,544 SF x \$4.69 SF =	\$11,931.36

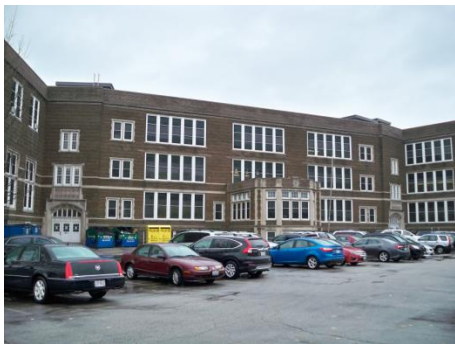
Parking spaces are limited

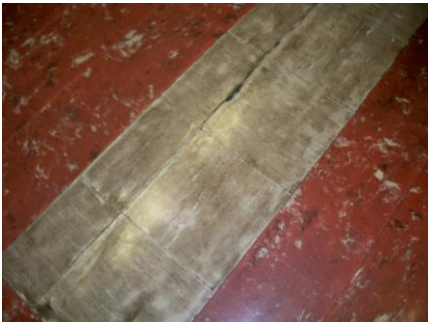
Vinyl Asbestos Floor Tiles

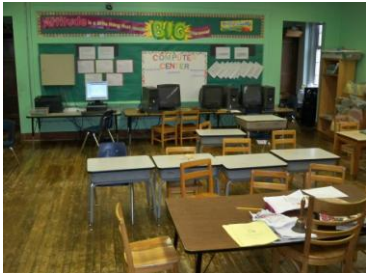
The typical furniture is generally mismatched, dated and in worn condition. It consists of student desks and chairs, teacher desks and chairs, desk height file cabinets, reading tables, computer workstations and bookcases.

Dated furniture

Provide for complete replacement of furnishings.

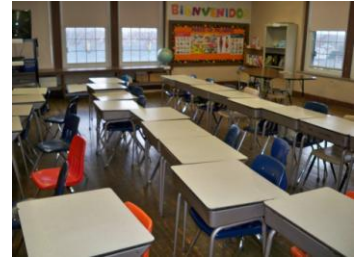
Mismatched furnishings
