**Building Information - Cleveland Municipal (43786) - Joseph M Gallagher Middle**

Program Type	Classroom Facilities Assistance Program (CFAP) - Regular
Setting	Urban
Assessment Name	Joseph Gallagher MS OSFC Update (June 2016)
Assessment Date (on-site; non-EEA)	2016-04-01
Kitchen Type	Full Kitchen
Cost Set:	2016
Building Name	Joseph M Gallagher Middle
Building IRN	62778
Building Address	6601 Franklin Blvd
Building City	hmmh
Building Zipcode	44102
Building Phone	216-961-0057
Acreage	5.00
Current Grades:	K-8
Teaching Stations	52
Number of Floors	3
Student Capacity	927
Current Enrollment	750
Enrollment Date	2001-05-31
Enrollment Date is the date in which the current enrollment was taken.	
Number of Classrooms	48
Historical Register	<b>NO</b>
Building's Principal	Tom Kubiak
Building Type	Elementary/Middle

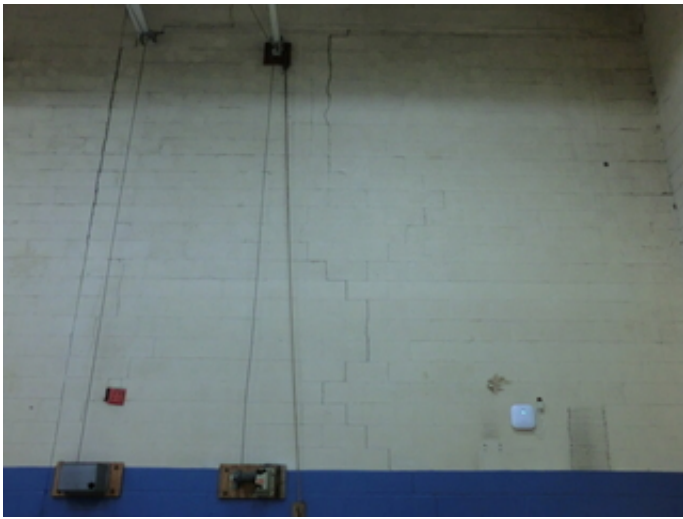
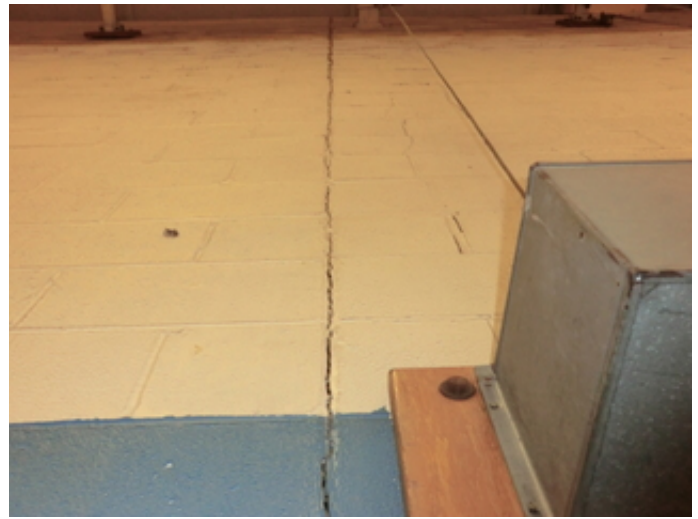
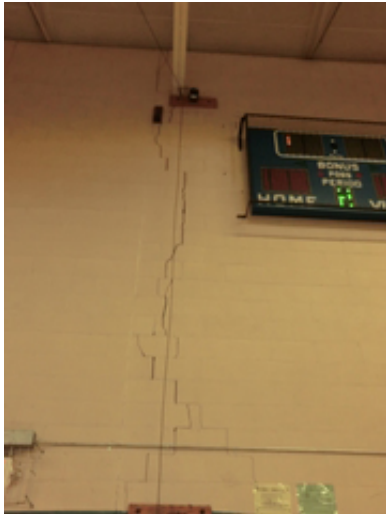
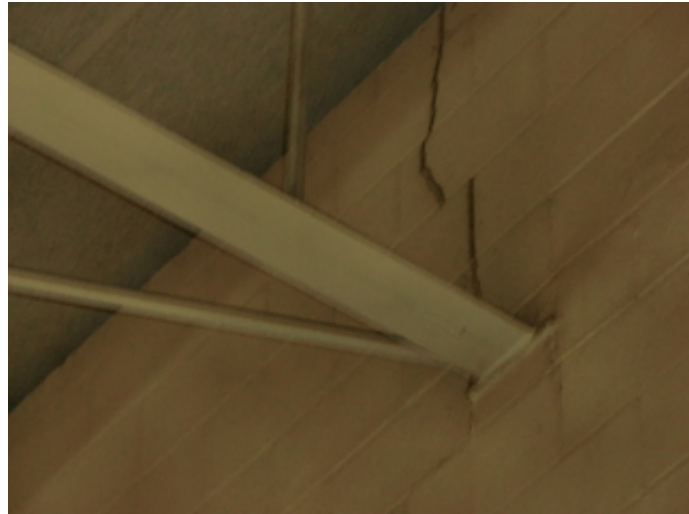
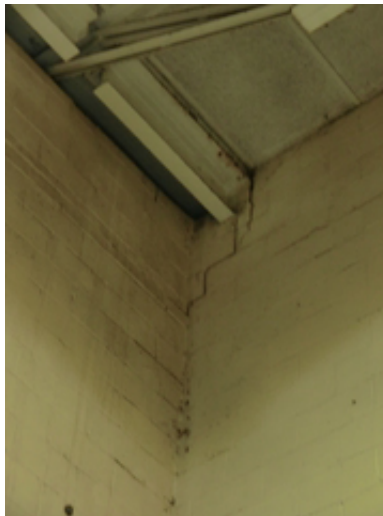
Numerous instances of vertically running cracks were observed below and above the joist seats in the load bearing walls of the gymnasium. Though the walls were constructed with control joints several cracks occurred at load bearing points. A detailed structural analysis should be performed on the gymnasium walls.

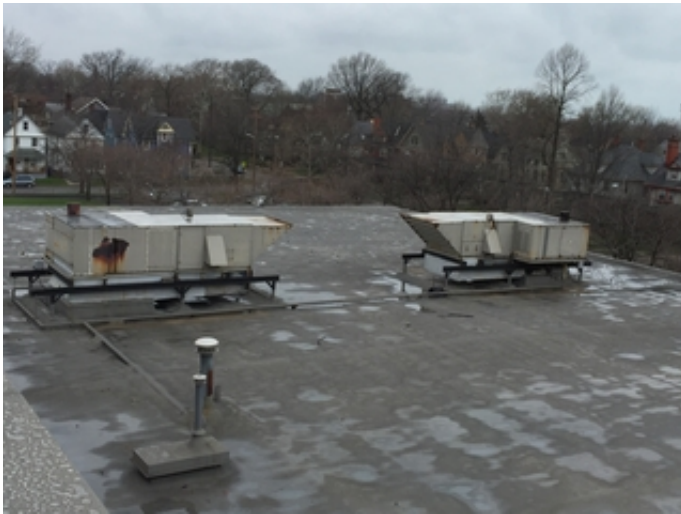
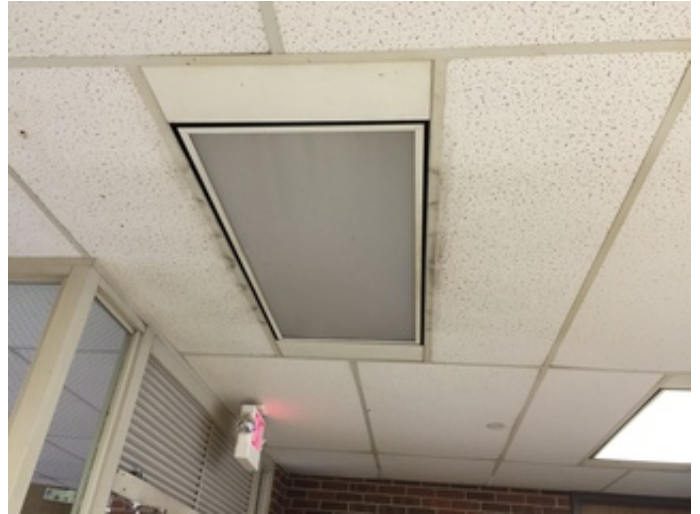
**Description:** The light fixtures are combination light fixture/air device. There is central air conditioning for this building but it is in poor condition and the overall system is not compliant with Ohio School Design Manual requirements. The general building exhaust systems located in the restrooms are functional and in satisfactory condition. There is no kiln in this facility and there is no Art Program Paint hood. The science rooms do not have a chemical hood.

**Rating:** 3 Needs Replacement

**Recommendations:** Provide an air conditioning system to meet OBC and OSDM requirements. Pricing included in Item A. Provide and Art program Paint Hood.

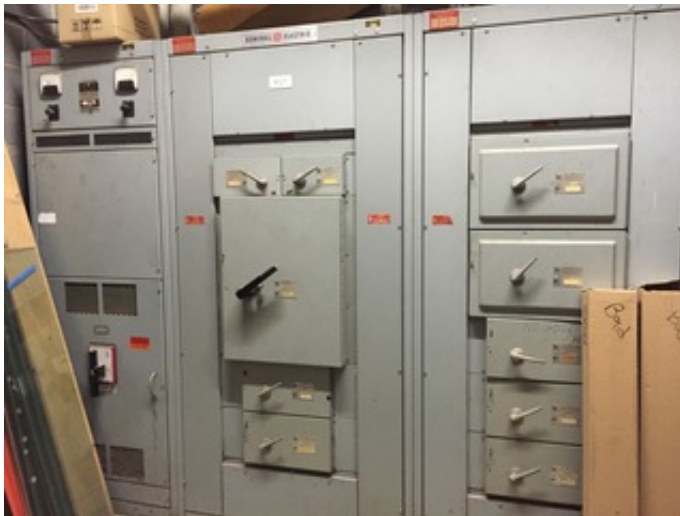
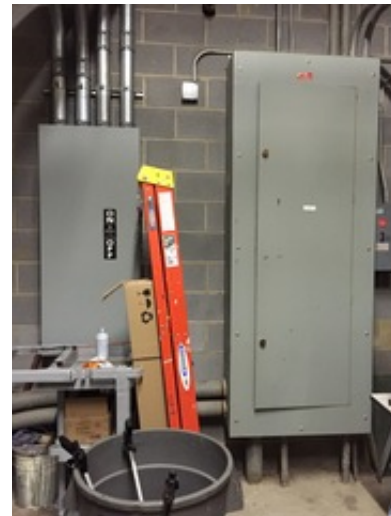
**Description:** The electrical system in the overall facility is a 480 volts, 1600 amps, three phase, and four-wire system. The electrical service was installed in 1977 and is in poor condition. The transformer is owned by the local utility. The panel system is in poor condition and was installed in 1977 and the facility has no additional spare capacity. The classrooms are not equipped with adequate electrical outlets. The main office and exterior of the building are not equipped with adequate electrical outlets for servicing. Extension cords are the primary power source for most of the main office. Adequate GFI protected exterior outlets are not provided around the perimeter of the building. There is no lightning protection. The overall electrical system does not meet OSDM requirements in supporting the current needs of the school and will be inadequate to meet the facility's future needs.

**Rating:** 3 Needs Replacement

**Recommendations:** The entire electrical system requires replacement to meet Ohio School Design Manual guidelines for overall capacity due to age. Upgrade service to 2800 amps minimum per OSDM guidelines.

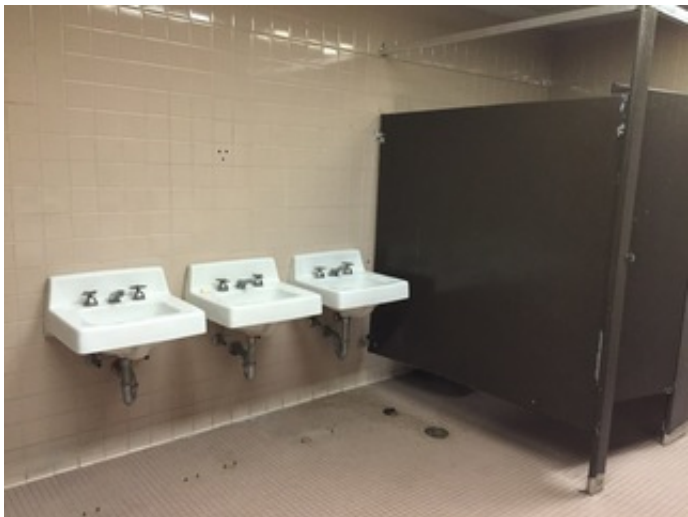
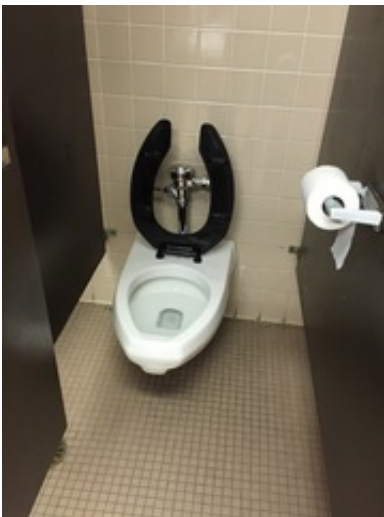
**Description:** There is one incoming 4" domestic supply and is in satisfactory condition. The sanitary waste piping is cast iron and is in good to fair condition. There is a backflow preventer on the water service line located inside the building and a meter in a pit outside. There were no water pressure issues indicated by the staff. There is no water treatment system for the domestic water system. The plumbing fixtures are original and faucets and flush valves replaced under normal maintenance. All of the flush valves and faucets are manual. There are wall mounted toilets. The plumbing fixtures are in poor to fair condition. The staff indicated that there are no isolation valves in the domestic system causing the system to be shut down every time there is a leak. There are an adequate number of hose bibbs provided around the perimeter of the building in satisfactory condition. The school contains 6 rest rooms for girls, 6 rest rooms for boys, and 9 rest rooms for staff. All of the toilets are wall mounted. The facility contains 14 toilets, 28 urinals, and 20 LAVs for boys and they are in fair to poor condition. The school contains 22 toilets, 1 ADA toilet, 2 ADA LAVs and 17 LAVs for girls and they are in poor to fair condition. The school contains 9 toilets, 2 urinals and 9 LAVs for staff and they are in fair to poor condition. There are 8 showers in each of the boys locker room and girls locker room. There are 12 drinking fountains, 1 Hi-low ADA electrical water cooler and 2 ADA water coolers in the school. The school meets the OBC requirements for fixtures, but the ADA requirements are not met for fixtures. There are an adequate number of hose bibbs provided around the perimeter of the building in good condition. The hot water heater system is in fair condition and the staff indicated the capacity was adequate. There are a total of 4 water heater in the building. There is a grease interceptor for the kitchen in this school.

**Rating:** 3 Needs Replacement

**Recommendations:** Replace 26 toilets, 30 urinals, and 48 lavatories with new fixtures to meet OSFC requirements. Replace 3 drinking fountains (one per floor) with ADA compliant drinking fountains.
