FACILITIES COST ANALYSIS
May 2015

Michael R. White PK-8 School
for the
Cleveland Metropolitan School District
1111 Superior Ave. E, Suite 1800
Cleveland, Ohio 44114
Phone: (216) 838-0000

Architectural Vision Group, Ltd.
23850 Sperry Dr.
Westlake, Ohio 44145
Phone: (440) 808-8520
Fax: (440) 808-8301

Building Assessment – Michael White PK-8 School

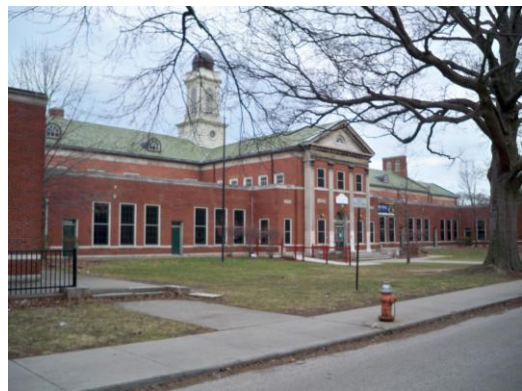
The roof system is clay tile on the sloped roofs, which appears in fair condition and an EPDM on the flat roofs. Several areas of ponding on the flat roofs were observed. The boiler house and the greenhouse also feature the same EPDM roofs. The ventilation system of the school is inadequate to meet the needs of the users.

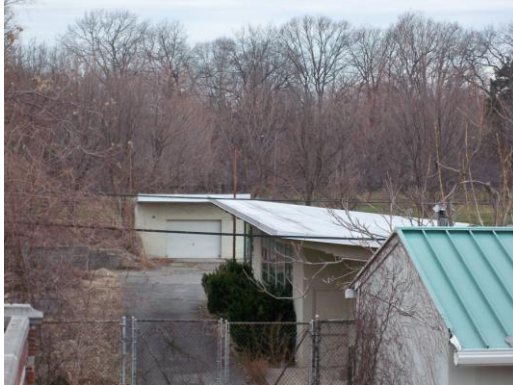
Greenhouse Roof (center bldg)

The roofs over the boiler house and the greenhouse are also EPDM systems and appear to be of the same installation date as the school roof. The boiler house utilizes internal roof drains for storm drainage, while the greenhouse utilizes a system of gutters and downspouts that are tied into the storm drainage system. Neither of the roofs have access. The roof over the detached classroom building is a metal roof system and utilizes gutters and downspouts.

The flat, EPDM roofs require replacement to meet Ohio School Design Manual guidelines for the age of the system and due to ponding conditions – this also includes the boiler house roof and the greenhouse roof. The clay tile roof will need to be replaced, and due to Historic Preservation requirements, the new roof will likely be required to be clay tile, instead of shingles, which is what the OSFC will co-fund. The difference in cost will be the District’s responsibility. The original roof hatch in the original building should be replaced.

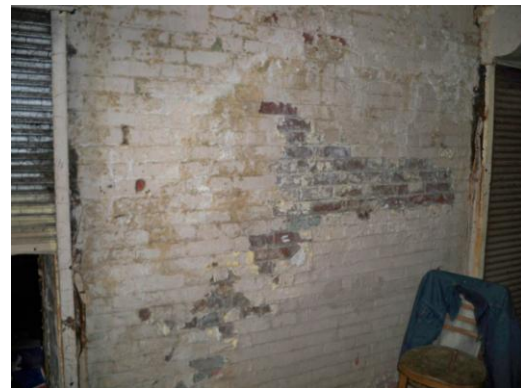
Interior brick wall in basement

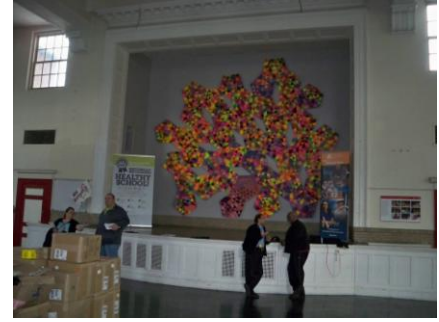
No lift at stage

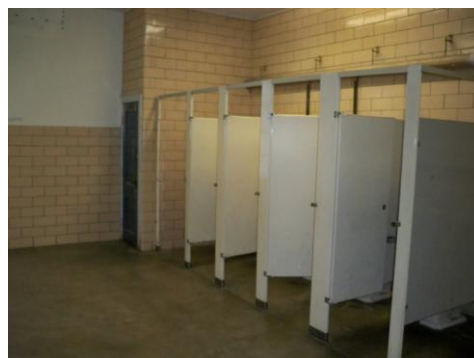
Non-ADA toilet partitions
