FACILITIES COST ANALYSIS
May 2015

Tremont Montessori PK-8 School
for the
Cleveland Metropolitan School District
1111 Superior Ave. E, Suite 1800
Cleveland, Ohio 44114
Phone: (216) 838-0000

Building Assessment and Cost Analysis for

Tremont Montessori PK-8 School

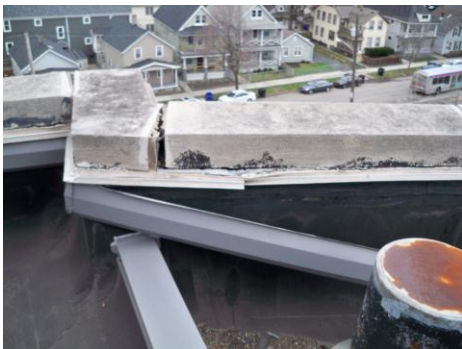
Coping joints exposed

The school has a flat, single-ply membrane roof system, which is reported to have been installed in 2001 and is in fair condition. There were no reports of current leaking, though signs of past leaking were observed inside the building. The roof has exceeded the age requirements by the OSFC, and will require replacement. Access was gained via two roof ladders which lead to roof access doors. They are in poor condition. The roofs utilize a system of internal roof drains and scuppers for evacuation of storm water and appear in fair condition. Minor areas of ponding were observed on the roof during the physical assessment. The parapet walls are equipped with stone coping, which have deteriorating joints leading to water penetration within the walls. There is no covered walkway attached to this structure.

The roof requires replacement to meet Ohio School Design Manual (OSDM) guidelines for the age of system. It is recommended that two roof ladders and roof access doors be replaced due to poor condition. Metal coping should be installed over existing stone coping to prevent further water penetration.

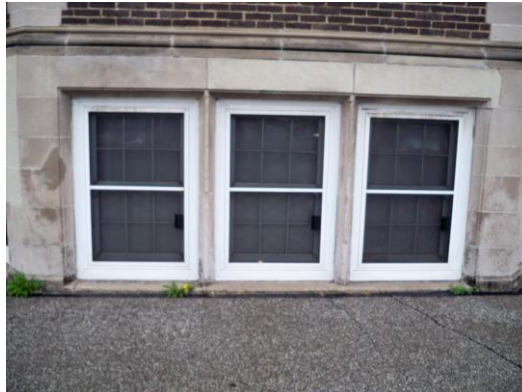
Typical Windows

The overall facility is equipped with thermally-separated, aluminum frame, double-glazed insulated window system. Windows were installed approximately 15 years ago and are in good condition. The typical window is an operable double-hung type system. Windows are equipped with insect screens which are generally in good condition. Window system seals appear to be in good condition with no air or water infiltration observed or reported. Window system

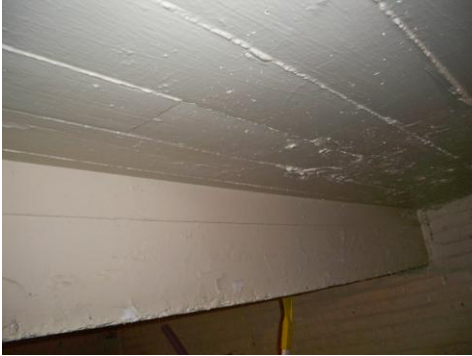
Intermediate floor construction

The floor construction of the basement level is concrete construction. There is no crawl space. The floor construction of the intermediate floors is cast-in-place concrete, and they are in fair to good condition where observed. The roof construction of the overall facility is cast-in place type construction, but could not be observed for evaluation of condition.

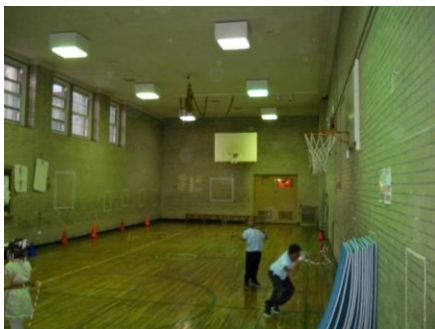
Gym finishes

The art program is located in the basement level and does not have a kiln. There are two small gyms in the basement level that are approximately 1,820 SF. The gyms have wood flooring in the ES-MS gym and vinyl asbestos flooring and carpet in the PK-K gym. Both feature 1'x 1' glued on ceilings which are in worn out condition. The walls in both gyms are brick. Neither gym has bleachers, and both gyms are equipped with 4 very worn fixed basketball backboards.

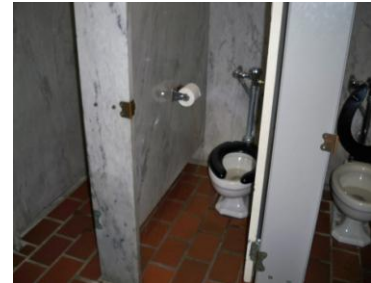
Non-ADA toilets & partitions

On the interior of the building, space allowances and reach ranges are mostly compliant. However, there is not an accessible route through the building's lower level due to steps at the gymnasiums which take those spaces a half level lower. Although there is an elevator in the building, it is an old freight elevator which remains locked to students and staff. Elevation changes within the building are facilitated by five (5) main stairwells, with two (2) smaller stairs in the storage rooms beside the gym that lead to upper storage rooms. Access to the stage is not facilitated by a lift or a ramp. Interior doors are a combination of non-recessed and semi-recessed old, wood units that do not feature ADA compliant hardware. The large group restrooms are not equipped with ADA compliant toilets, toilet partitions, sinks or urinals. The building lacks ADA compliant electric water coolers as well. ADA signage is not provided.

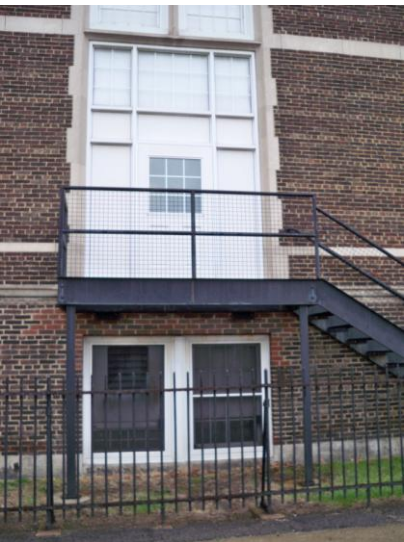
Fire escape stair

The overall facility is not equipped with an automated fire suppression system. The facility is not currently equipped with an emergency generator. The facility features three (3) dead end corridors where the corridor previously connected to another building that was subsequently demolished. The two (2) gyms do not have the proper means of egress as required for spaces with more than 50 occupants. The interior stairwells are enclosed, but not with proper magnetic hold-open devices, two-hour fire-rated enclosures. The handrails and guardrails in the stairwells are not compliant with current Ohio Building Code requirements. There are no handrails at the stage steps. The facility has two fire escape exterior stairs – both attached to the auditorium/cafeteria which are not permitted as means of egress any longer by building code. Fire extinguishers were observed in the facility. There is no kitchen hood to evaluate in this building, as it contains a warming kitchen only.

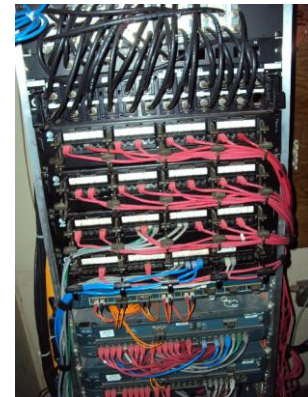
Typical technology rack on IT closet

Most classrooms are equipped with 1 or 2 data outlets. A two-way PA system is provided that each room can call the main office in case of an emergency. There are no phones provided in each classroom. A typical classroom has a single data cable that is branched off with either a router or net switch located in each room.
